S₂ Partnership Ltd
Intelligent Risk Management

Asbestos Management

1st August 2018

Enterprise House
9 Martinfield
Welwyn Garden City
AL7 1HG

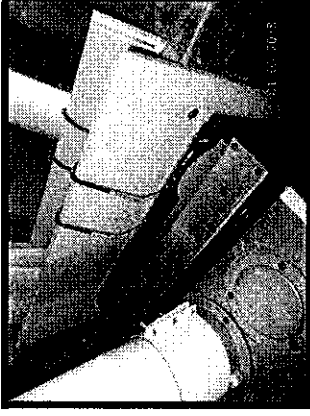
<p>Supalux panel to rear of boiler unit.</p>

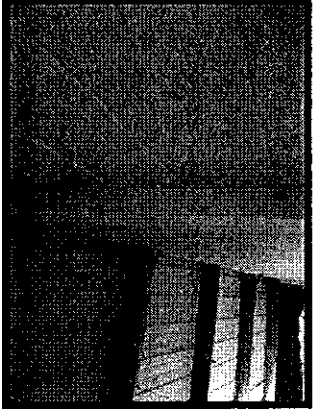
<p>Painted Vicuclad fire protection to columns</p>	
<p>011</p>	<p>Office: Carpet tiles over a timber floor, plasterboard walls and a suspended MMMF tiled ceiling with a profiled metal sheet roof above were observed in this area.</p> <p>Painted Vicuclad (Modern fire protection) boards were also observed to the columns in this area.</p> <p>No asbestos containing materials were observed in this area at the time of the survey.</p>		
<p>012</p>	<p>Corridor: Carpet tiles over a timber floor, plasterboard walls and a suspended MMMF tiled ceiling with a profiled metal sheet roof above were observed in this area.</p> <p>No asbestos containing materials were observed in this area at the time of the survey.</p>

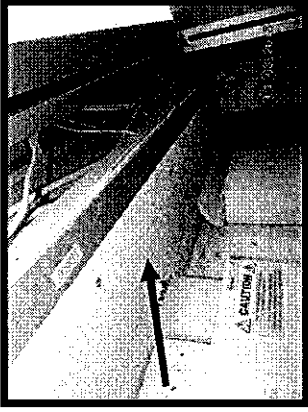
<p>Sample ref: EH/SS/G/014/001</p>

SCOPES SAMPLE No.	CLIENT SAMPLE No.	Sample Location	Fibre Type Detected
1	EH/SS/G/014/001	TEXTURED COATING	NADIS

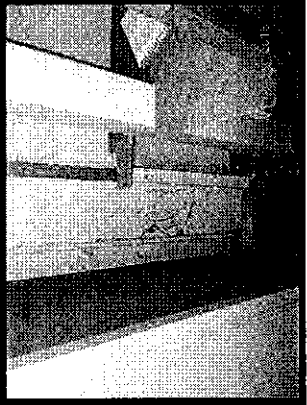
<p>Damaged Vicuclad fire protection to column</p>
EXT	<p>External Areas: A concrete floor, brick and profiled metal sheet walls and profiled metal sheet roof were observed in this area.</p> <p>Metal gutter and plastic downpipes were also observed in this area.</p> <p>No asbestos containing materials were observed in this area at the time of the survey.</p>
