# Building Inspection Report

People Express Taxis  
Unit 2, rear of 25 Somers  
Rugby  
CV22 7DG

Report date: 5<sup>th</sup> October 2023

**Job reference:** MD/SR/21780

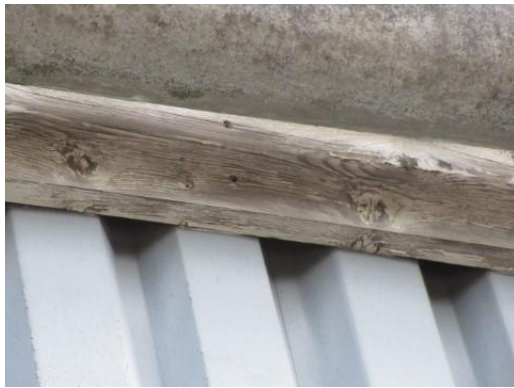
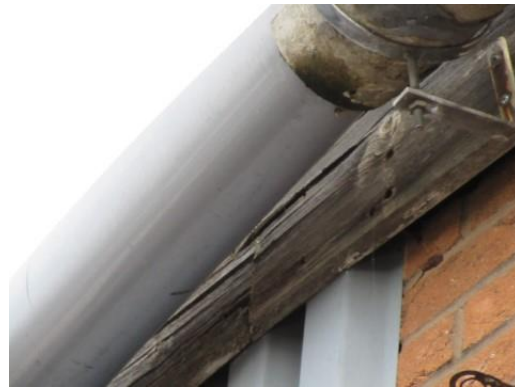
The timber fascia is in poor decorative order and we recommend this is prepared and redecorated in the short term to prevent any further deterioration.

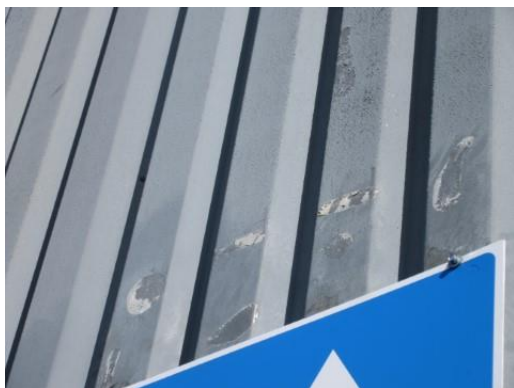
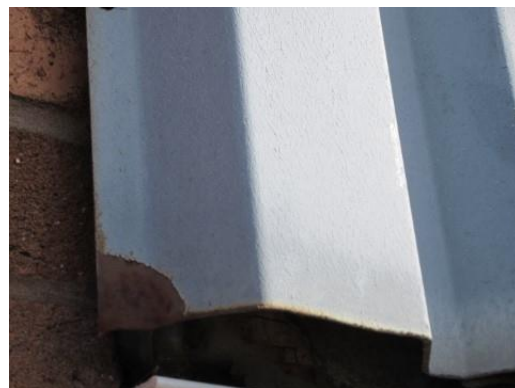
The metal cladding at high level and to the front wall is scuffed and marked with corrosion noted to the cut edges adjacent the door opening and at high level. Dents and marks are noted adjacent the left-hand side of the roller shutter though in general the metal cladding is in a reasonable condition, however a budget should be provided for maintenance works in the medium term.

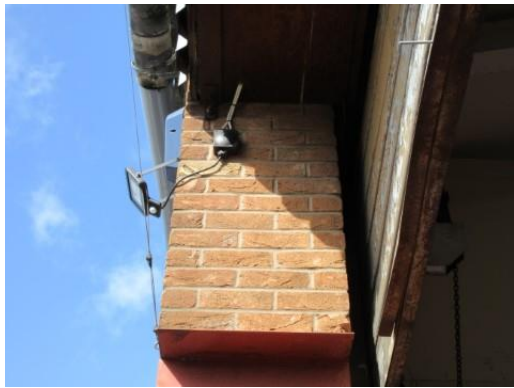
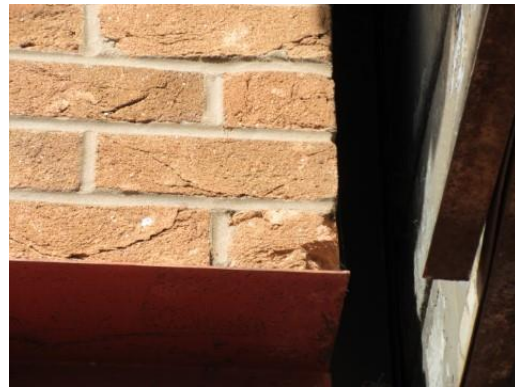
The brickwork at high level above the head of the roller shutter is in a reasonable condition though we do note slight damage to the corner brick, however we would recommend monitoring at present and replacement as required.

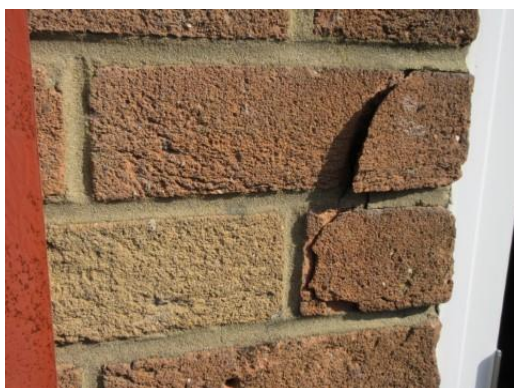
We noted damage to the brickwork and we are of the opinion is due to the installation of the doorframe. We therefore recommend the brick is replaced to prevent any further deterioration of the adjacent brickwork.

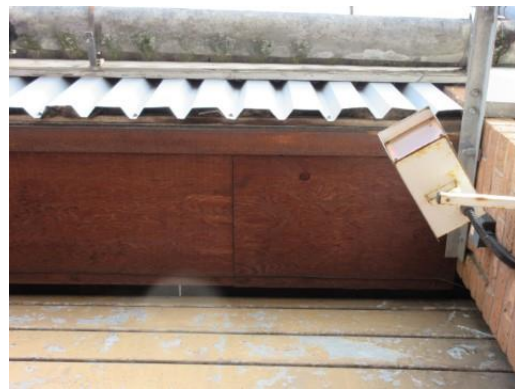
The high level plywood to the underside of the head of the roller shutter generally appears in a reasonable condition. We do note a fan and we are of the opinion is not currently in use therefore if not required should be removed and all services taken back to source.

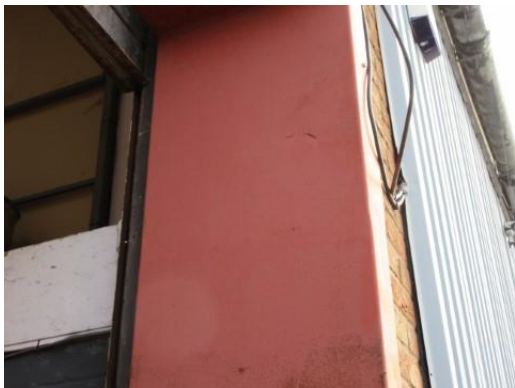
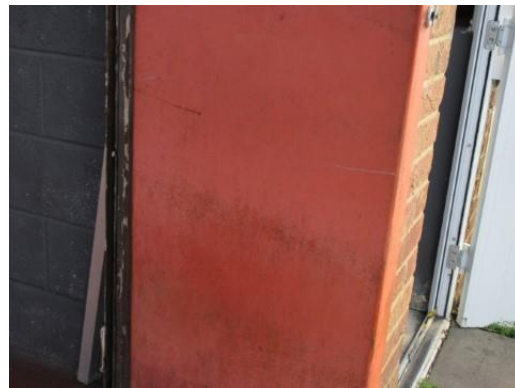
The steel cladding to the cheeks of the roller shutter is noted to be corroded in areas and would benefit from preparation and redecoration.

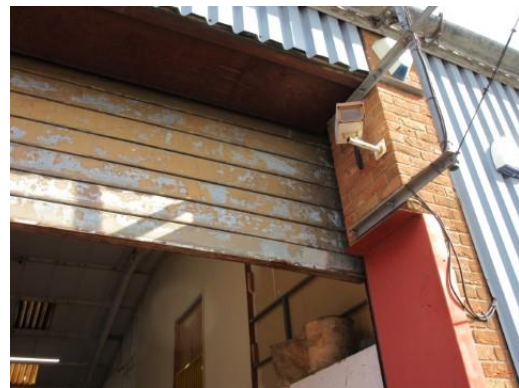
The roller shutter is in poor decorative order with the lower guide uneven and out of alignment therefore we recommend repairs be undertaken, preparation and redecoration and annual servicing be carried out.

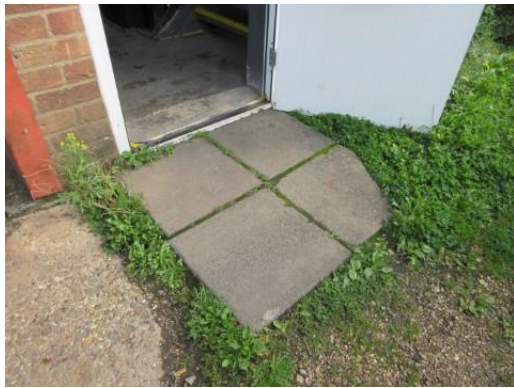
The paving adjacent the front entrance door is noted to be slightly out of alignment and a trip hazard which may have been caused by the installation therefore we recommend an upstand and handrail applied adjacent the lower edge. Notwithstanding this the slabs generally appeared in a reasonable condition.

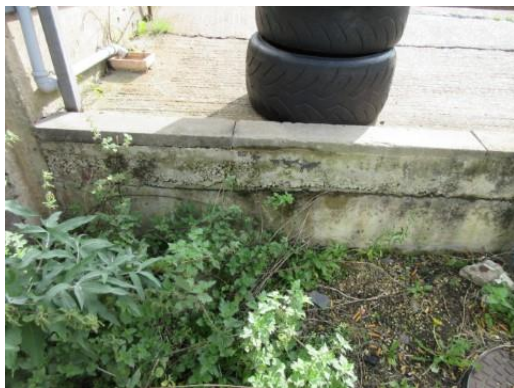
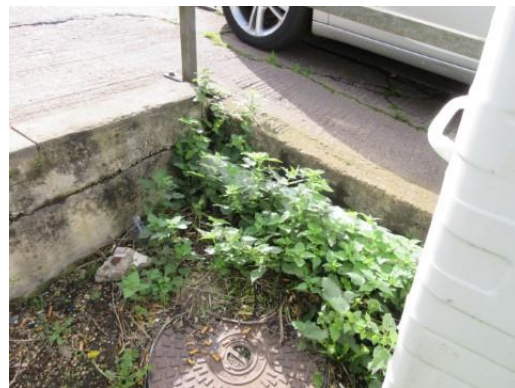
The blockwork retaining wall to the adjacent property is heavily stained. We therefore recommend that this be cleaned down and all joints repointed to prevent any further deterioration.

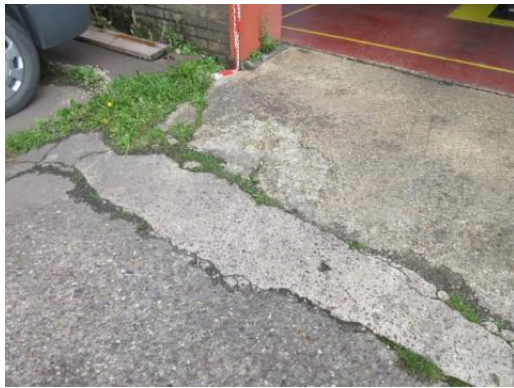
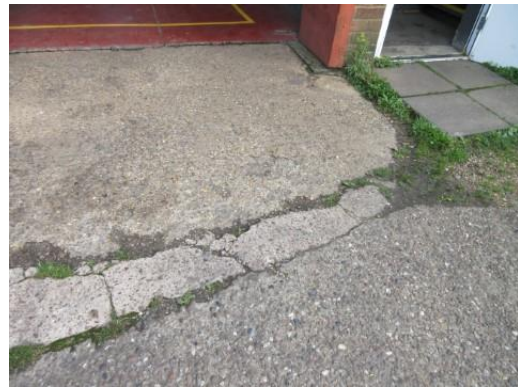
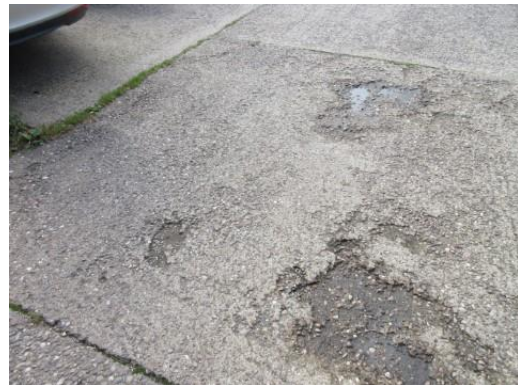
The concrete to the front section is noted to be cracked to the corners with vegetation to the joints, pitting, undulation and service ducts created. Therefore we recommend all areas are cleaned down and repaired in the short to medium term to prevent any further deterioration.

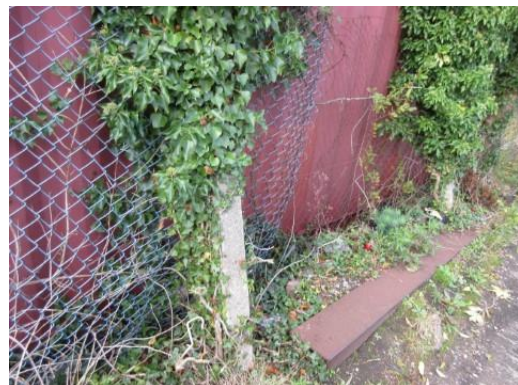
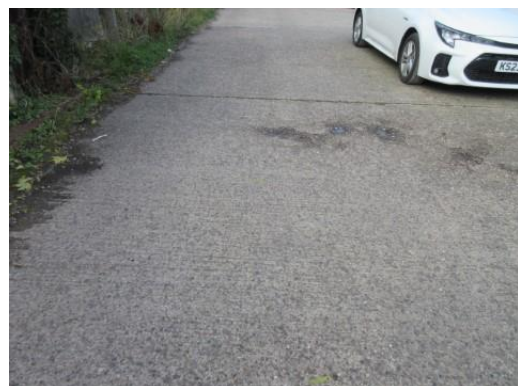
We recommend that your solicitor advises of full boundaries and any service charge for the upkeep of the adjacent fence which is noted to be in poor condition and the access road.

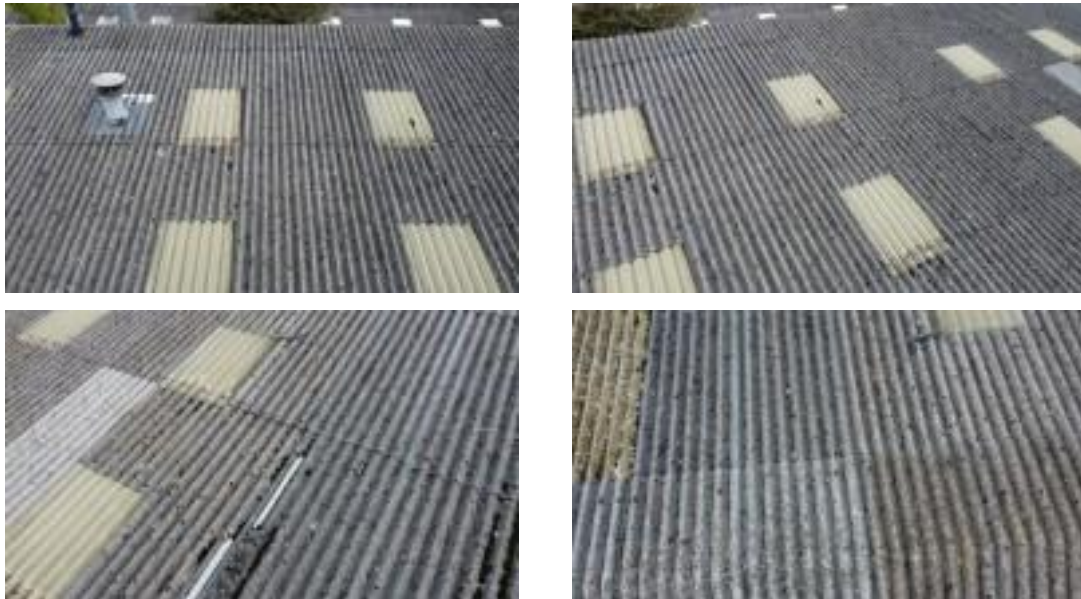
The sheeting to the front slope of the main roof was noted to be moss and lichen covered in addition to staining of the sheets, though no areas of roof covering were noted to be cracked or damaged.

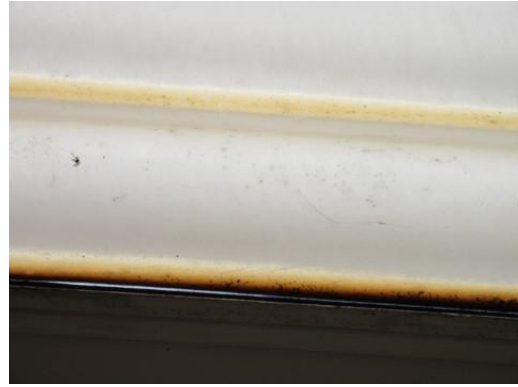
A translucent corrugated rooflight is evident which is noted to be UV degraded externally. General wear and tear was also evident and a small void to the junction of the frame was apparent, however, no cracking or damage was evident.

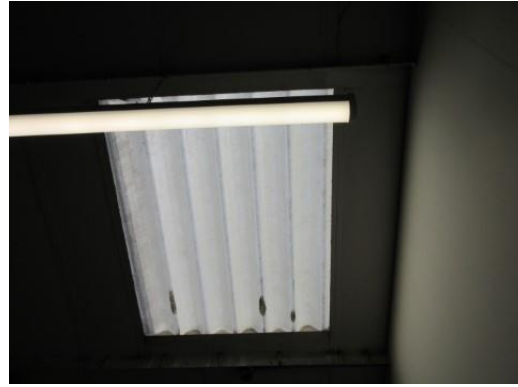
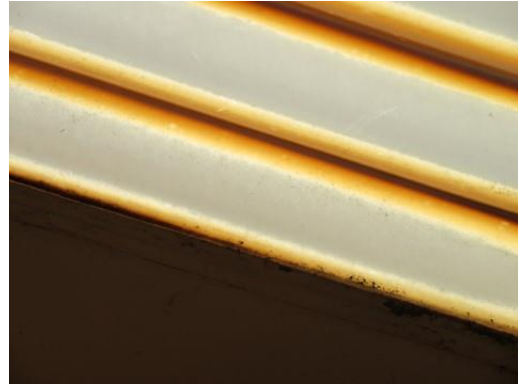
A translucent corrugated rooflight is evident which is UV damaged externally. General wear and tear noted and a small void evident to the junction of the frame, however, no cracking or damage was evident.

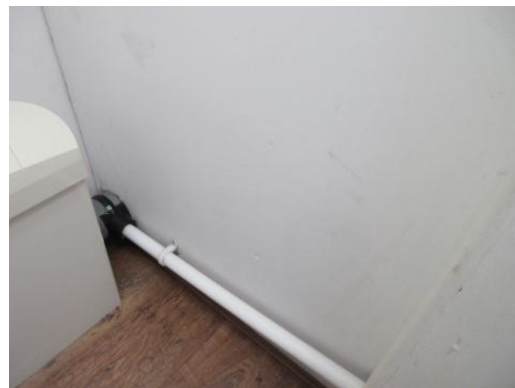
A small vanity unit was evident. The flow at the taps was satisfactory and drained away sufficiently with no obvious leaks noted. However, no splashback was provided therefore water damage may occur to the rear though was only stained at the time of the inspection.

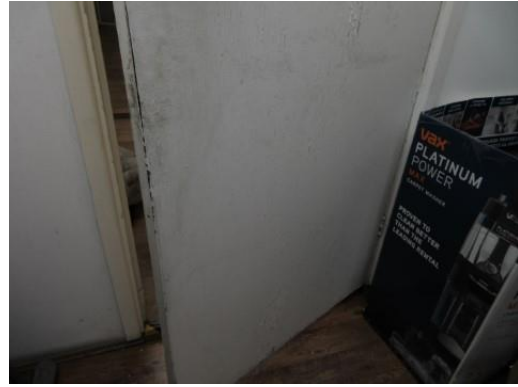
The internal painted flush door was in poor decorative order internally and would benefit from preparation and redecoration including all doorframes and architraves.

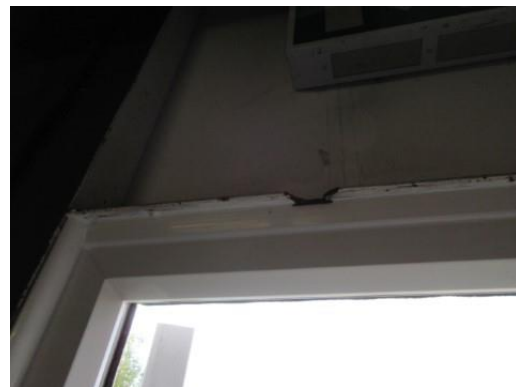
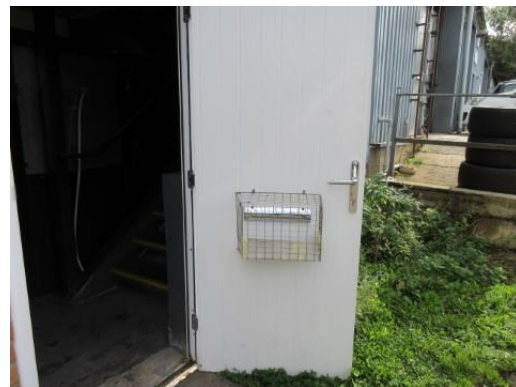
The external door is noted to be composite. We note the seal to the threshold is damaged and requires replacement. A small void is noted above the head of the doorway which should be infilled to prevent any water ingress which may cause dampness. Generally the door was in a good usable condition.

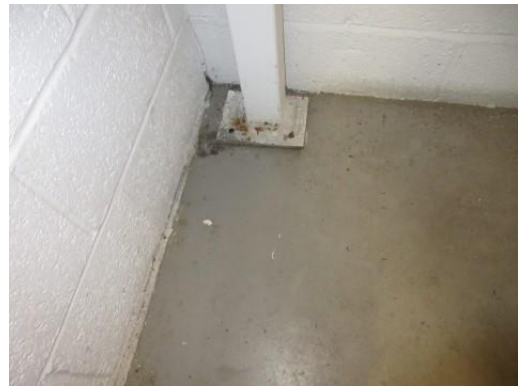
The steel support to the staircase generally appears in a reasonable condition however we did note that the base plate had been cut and the bolts not installed. However, no movement or cracking was evident to the mezzanine or adjacent structure.

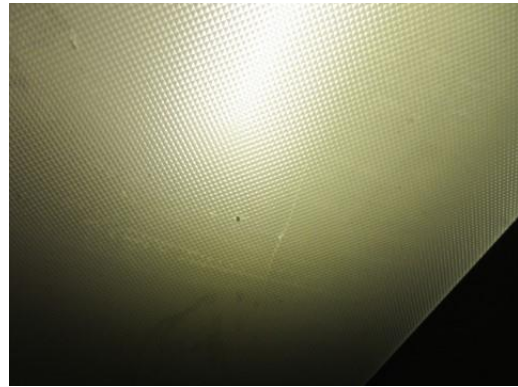
The diffusers were noted to be heavily soiled with 4 no. noted to be damaged.
