## Siteguard For Barclays

NORTHERN GARAGE, HOUGHTON ROAD, NORTH ANSTON, ROTHERHAM, S25 4JJ

### **Professional opinion**

Conveyancing Information Executive Ref: GS-8118203 Your ref: non\_rec\_pba Grid ref: 451067 385533 Date: 13 August 2021

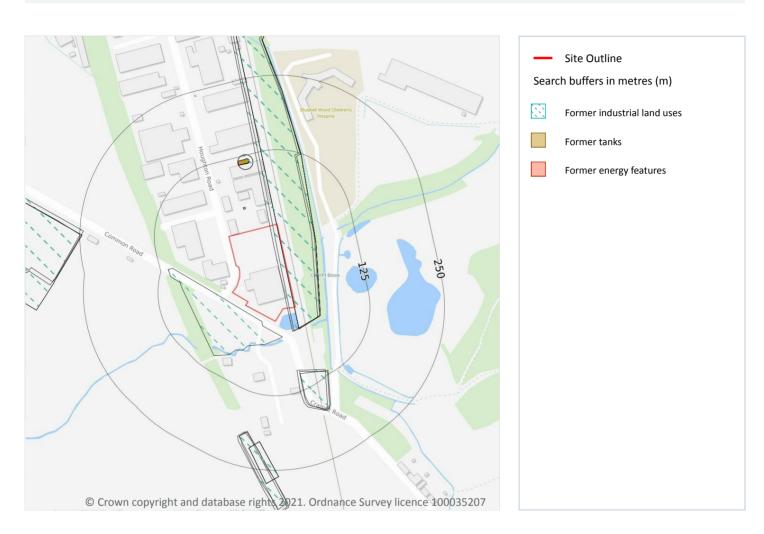
## Contaminated land / Past land use

### Former industrial land use (1:10,560 and 1:10,000 scale)

These historical land uses have been identified from 1:10,560 and 1:10,000 scale Ordnance Survey maps dated from the mid to late 1800s to recent times. They have the potential to have caused ground contamination. Please see the Environmental Summary to find out how these could impact the site.

Distance	Direction	Use	Date
0	on site	Mineral Railway Sidings	1931
0	on site	Railway Sidings	1948
0	on site	Mineral Railway Sidings	1951
0	on site	Mineral Railway Sidings	1967
0	on site	Mineral Railway Sidings	1979

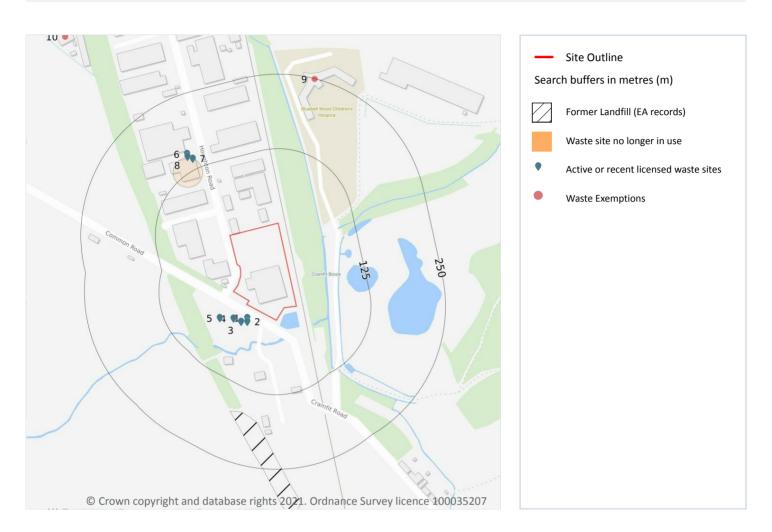
## Contaminated land / Waste and landfill

### Waste site no longer in use

These are records of former waste storage, treatment or transfer sites that have been identified from high detailed historical maps or Local Authority planning records. Depending on the nature of the waste that was handled and stored at these facilities, there may be a risk of ground contamination.

Distance	Direction	Details		
102 m	NW	Type of Site: Recycling Facilities Site Address: MVS Recovery, Stainforth, Works, Houghton Road, North, Anston Trading Estate, North, SHEFFIELD, South Yorkshire, S25 4JJ	Further Details: Scheme comprises use of premises for depolluting end of the life vehicles. An application (ref: RB2007/0078) for detailed planning permission was granted by Rotherham B.C. Planning decision obtained Data Source: Historic Planning Application Data Type: Point	Details: RB2007/0078 Date: -

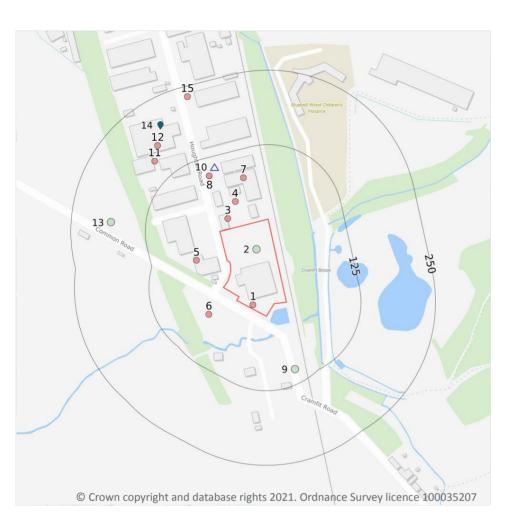
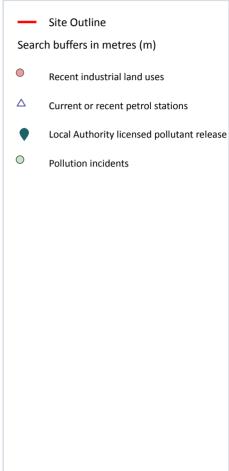
## Contaminated land / Current and recent industrial

#### **Recent industrial land uses**

These records show details of businesses that have recently operated, or are currently operating in the area. Depending on the type of activities taking place, some of these businesses could present a risk of contamination.

ID	Distance	Direction	Company / Address	Activity	Category
1	0	on site	Sewage Pumping Station - South Yorkshire, S25	Waste Storage, Processing and Disposal	Infrastructure and Facilities
3	18 m	N	Business Centre - South Yorkshire, S25	Business Parks and Industrial Estates	Industrial Features
4	42 m	N	Electricity Sub Station - South Yorkshire, S25	Electrical Features	Infrastructure and Facilities

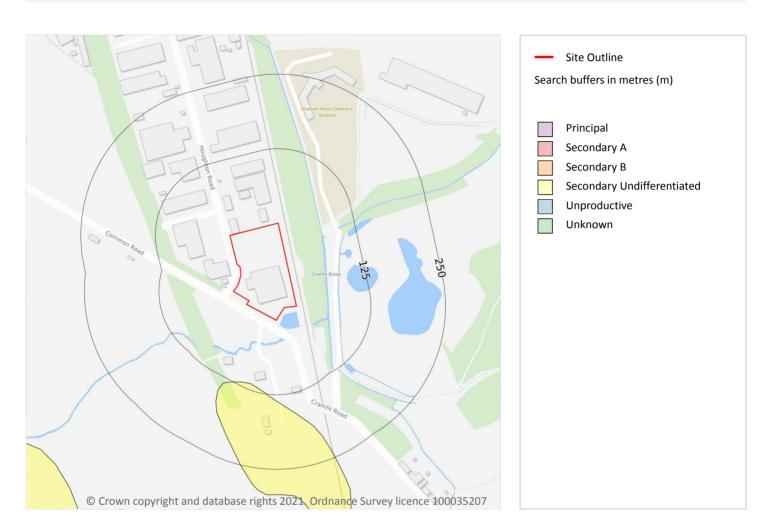
## Superficial hydrogeology

### Aquifers within superficial geology

The Environment Agency/Natural Resources Wales and the British Geological Survey have assigned designations or types to the aquifers that exist within superficial geology. These designations reflect the importance of aquifers in terms of groundwater as a resource (eg drinking water supply) but also their role in supporting surface water flows and wetland ecosystems.

Distance	Direction	Designation
115 m	S	Secondary Undifferentiated

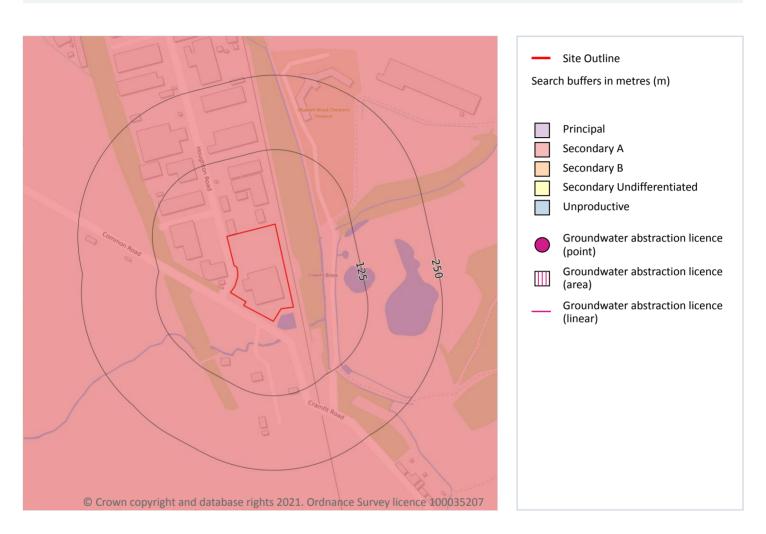
## **Bedrock hydrogeology**

### Aquifers within bedrock geology

The Environment Agency/Natural Resources Wales and the British Geological Survey have assigned designations or types to the aquifers that exist within bedrock geology. These designations reflect the importance of aquifers in terms of groundwater as a resource (eg drinking water supply) but also their role in supporting surface water flows and wetland ecosystems.

Distance	Direction	Designation
0	on site	Secondary A

Description	BGS LEX Code	Rock Type
PENNINE UPPER COAL MEASURES FORMATION	PUCM-MDSS	MUDSTONE, SILTSTONE AND SANDSTONE

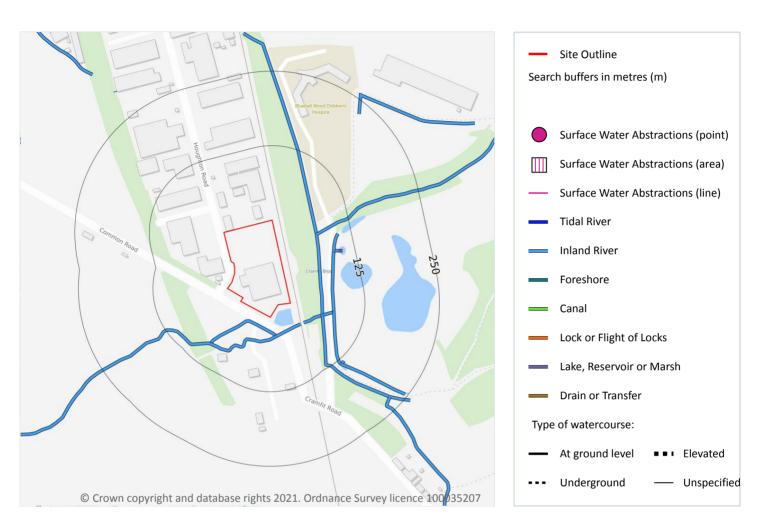
## **Hydrology**

### **Water courses from Ordnance Survey**

These are water features such as ponds, lakes, rivers and streams that have been identified by Ordnance Survey. These features may be sensitive to contamination.

Distance	Direction	Details
22 m	SW	Name: Type of water feature: Inland river not influenced by normal tidal action. Ground level: On ground surface Permanence: Watercourse contains water year round (in normal circumstances)
33 m	SE	Name: Cramfit Brook Type of water feature: Inland river not influenced by normal tidal action. Ground level: On ground surface Permanence: Watercourse contains water year round (in normal circumstances)

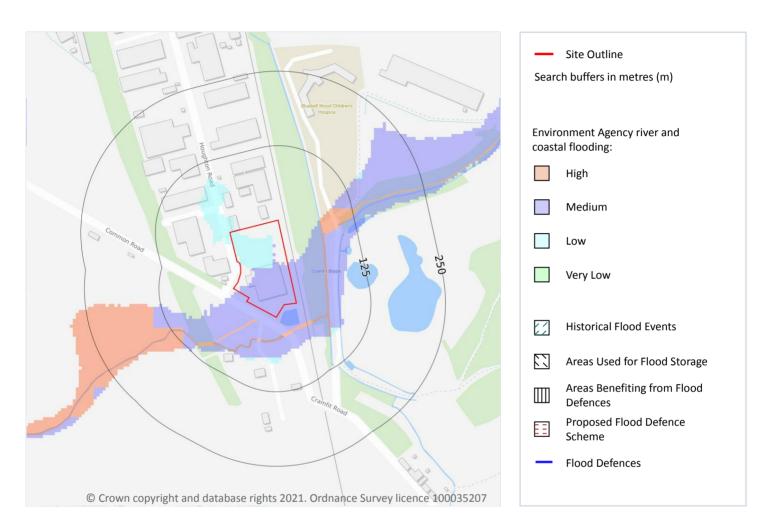
## **Flooding** / Risk of flooding from rivers and the sea

### Risk of flooding from rivers and the sea

The property has a Medium chance of flooding in any given year, according to Risk of Flooding from Rivers and Sea (RoFRaS) data. This could cause problems with insuring the property against flood risk.

RoFRaS assesses flood risk from rivers and the sea in England and Wales, using local data and expertise. It shows the chance of flooding from rivers or the sea, taking account of flood defences and the condition those defences are in. The RoFRaS model uses local water level and flood defence data to model flood risk. See below for explanation of the RoFRaS levels of flood risk.
