# Building Inspection Report

People Express Taxis  
Unit 2, rear of 25 Somers  
Rugby  
CV22 7DG

Report date: 5<sup>th</sup> October 2023

**Job reference:** MD/SR/21780

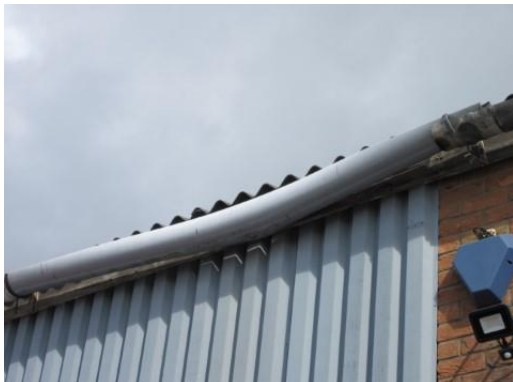
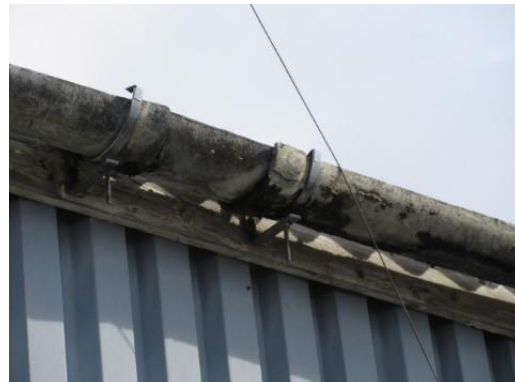
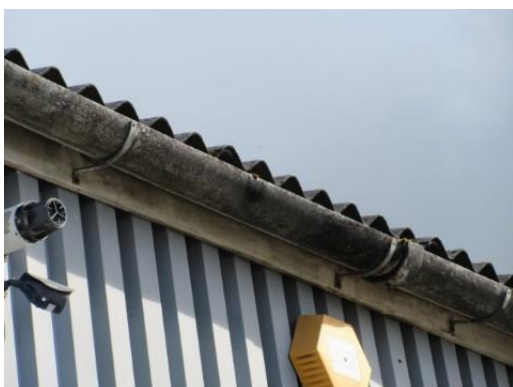
The timber fascia is in poor decorative order and we recommend this is prepared and redecorated in the short term to prevent any further deterioration.

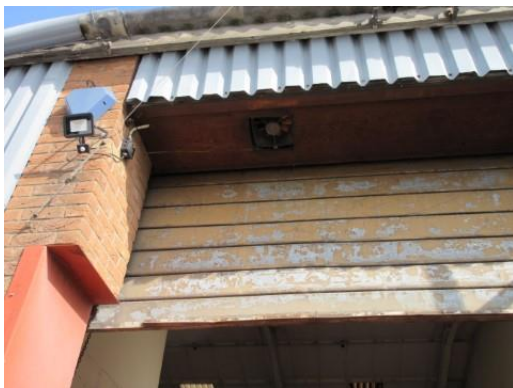
No testing of the cameras or alarms was carried out therefore we recommend a suitably qualified electrician test and recommission all external items.

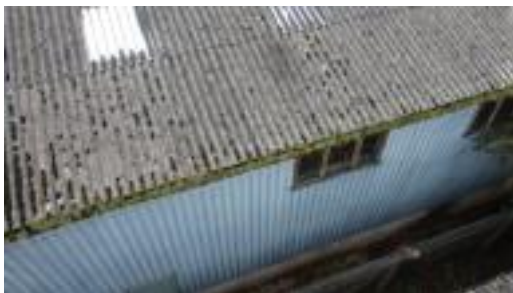
The cladding to the rear was noted to be heavily stained, scuffed and marked with minor dents evident however was generally in a serviceable condition.

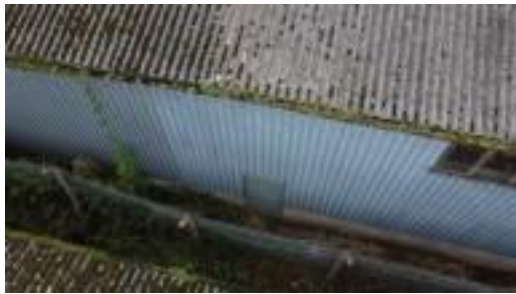
The timber window at high level to the rear elevation was in poor decorative order with some decay evident to the cill therefore we recommend in the short term the external timbers are prepared and redecorated to prevent any further deterioration.

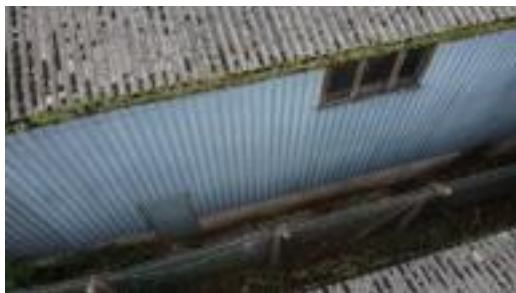
The blockwork at low level was noted to be stained. We are of the opinion this is due to leaking gutters in addition to vegetation along the stone wall to the rear. We therefore recommend that the guttering is repaired in the immediate term to prevent any further staining or deterioration.

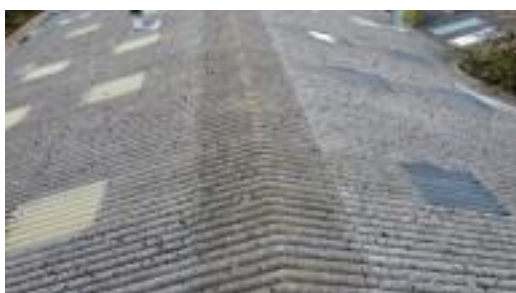
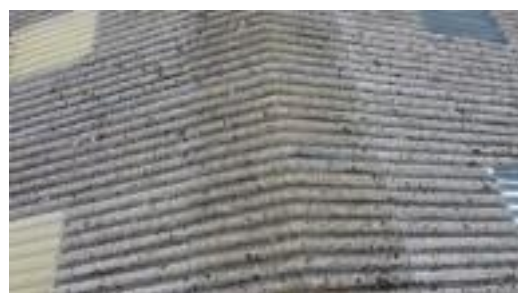
The sheeting to the front slope of the main roof was noted to be moss and lichen covered in addition to staining of the sheets, though no areas of roof covering were noted to be cracked or damaged.

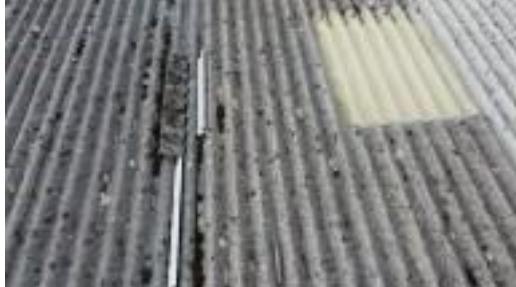
1 no. new section of corrugated sheeting has been installed and all generally appeared to be in a reasonable condition as no leaks were noted internally.

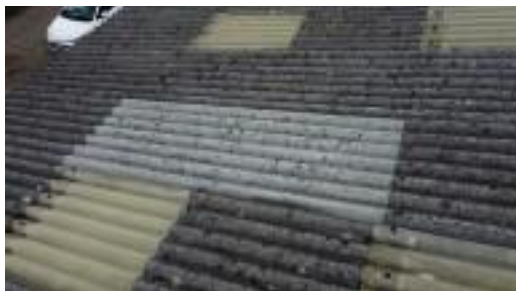
The rooflights were noted to be all UV damaged therefore if further natural light is required, we would advise that the rooflights be exchanged. We would also recommend that they be

cleared and the junctions with the roof covering are resealed to prevent any possible water ingress.

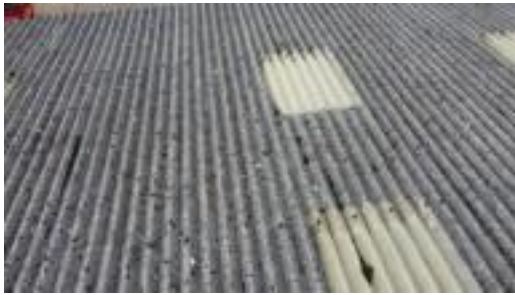
We also note that the translucent roof sheets to the rear are warped to the edges therefore causing the void internally to the junction with the roof sheets. We therefore recommend these are repaired in the immediate term to prevent any wind driven rain entering the roof space.

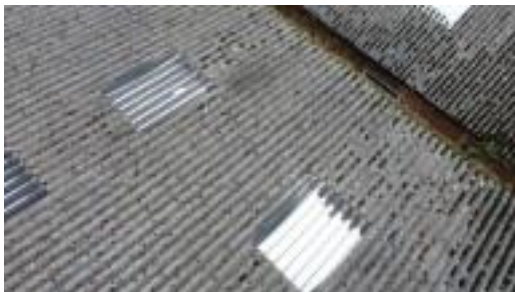
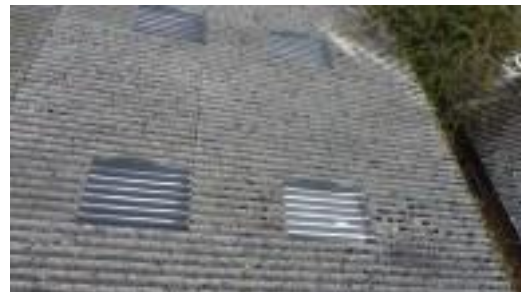
The roof sheet covering to the slope was heavily covered with vegetation and moss due to the overhanging tree. We also note 1 no. section of damage to the roof covering adjacent the ridge which should be sealed or replaced in the immediate to short term to prevent further cracking of the roof sheet.

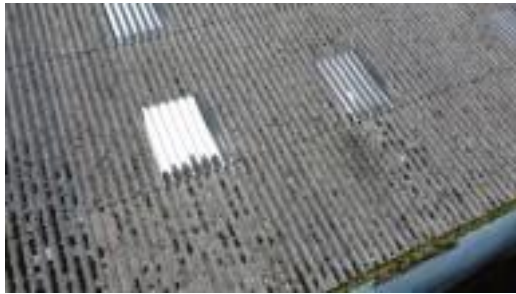
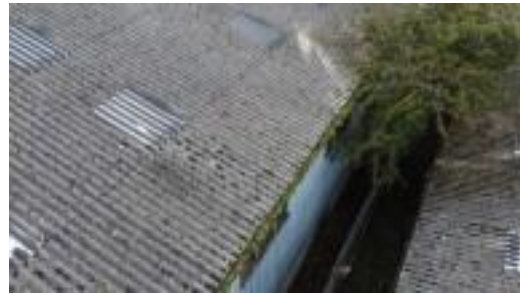
The guttering to the front elevation was noted to be heavily silted in addition to the poor condition of the adjacent PVCu guttering. We therefore recommend this is cleared, repaired or replaced within the short term to prevent any further deterioration.

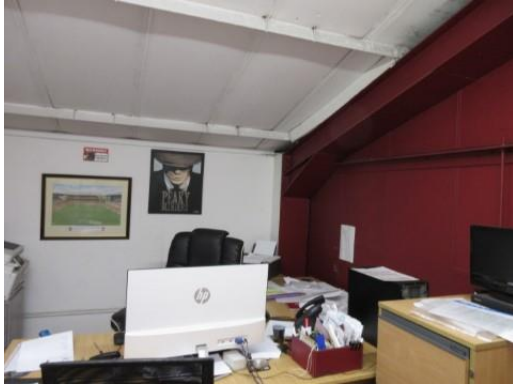
The underside of the main roof sheets is noted to be insulated board with a painted finish. Minor soiling and impact damage is evident, though no staining noted and all generally appeared to be in a reasonable condition and fit for purpose.

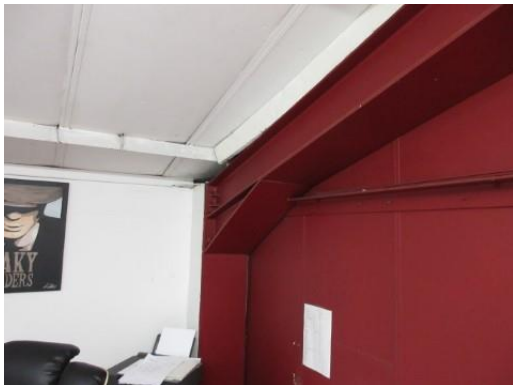
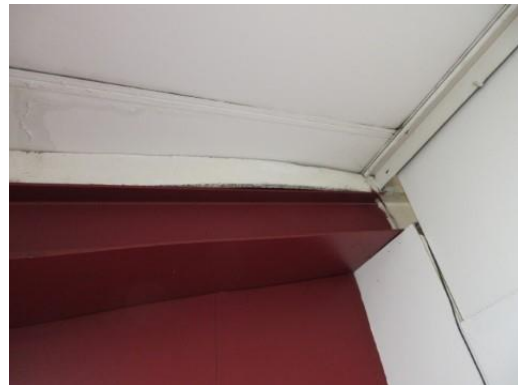
The internals have been overclad with boarding with a painted finish. Slight damage is noted to the junction of the joints of the boarding, heavily soiled in areas and stained though noted to be installed as a temporary partition with no further defects evident.

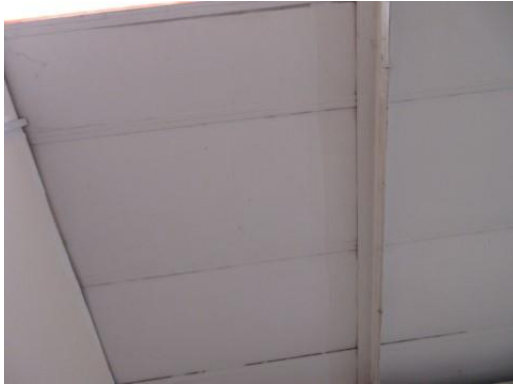
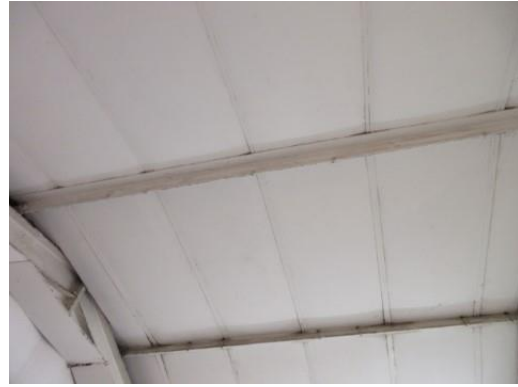
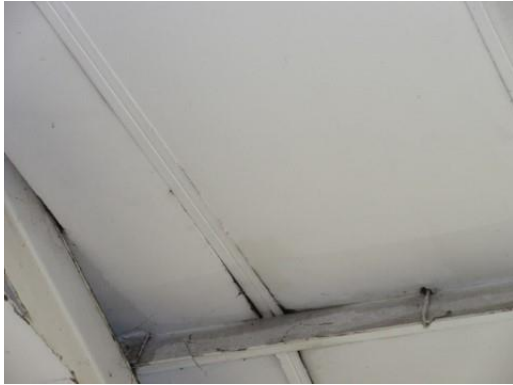
The painted steel angle purlins generally appeared to be in a reasonable condition, heavily soiled though no obvious deviation or undulations noted.

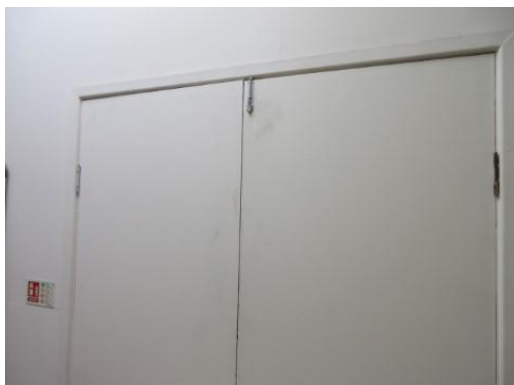
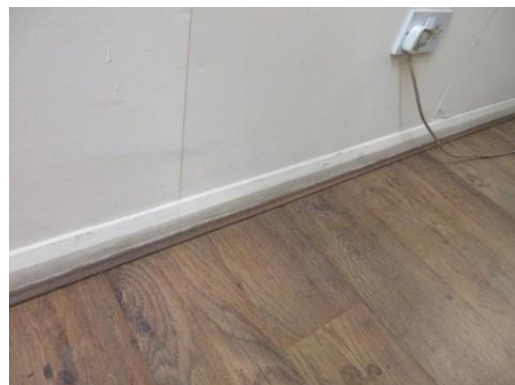
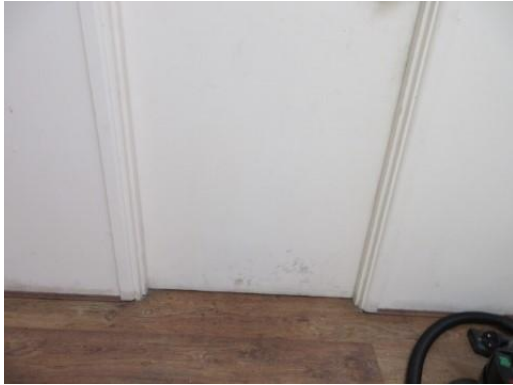
The joinery consists of gloss painted internal doors, frames, architraves and skirting. All heavily scuffed and marked and would benefit from preparation and redecoration, though generally in reasonable condition.

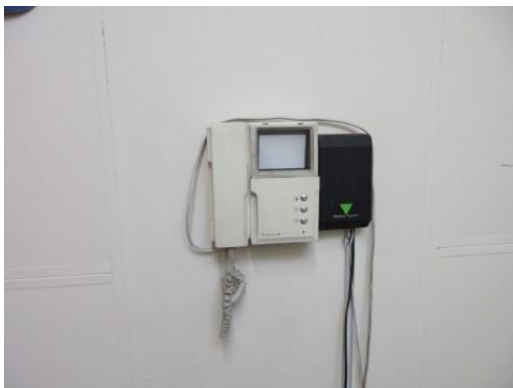
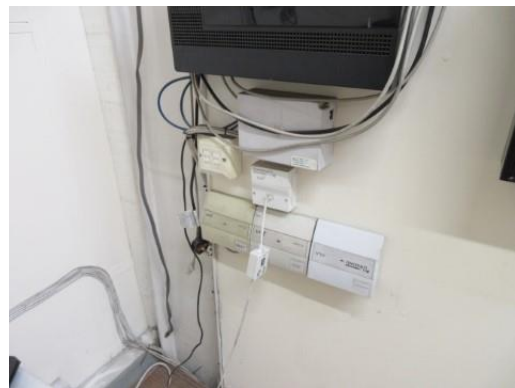
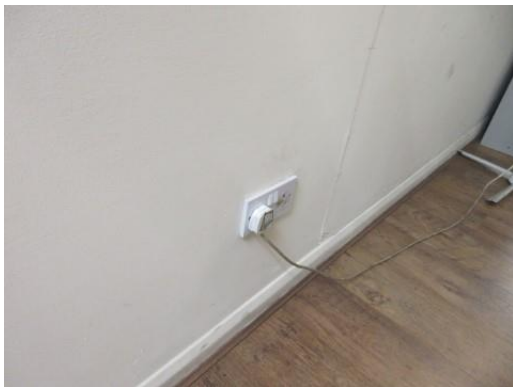
We note an intercom system and various electrical appliances and installations therefore we recommend all are serviced within the previous 12 months, in addition to a suitably qualified electrician test and identify any defects and rectify as necessary.

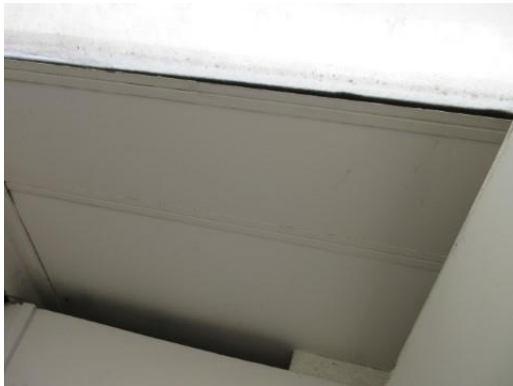
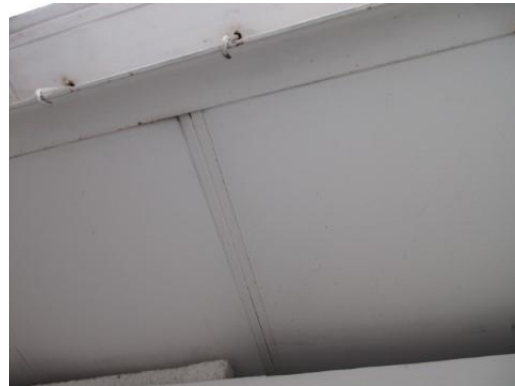
The underside of the main roof sheets is noted to be insulated board with a painted finish. Minor soiling and impact damage is evident, though no staining noted and all generally appeared to be in a reasonable condition and fit for purpose.

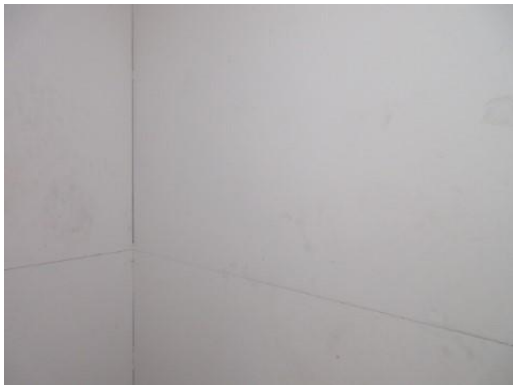
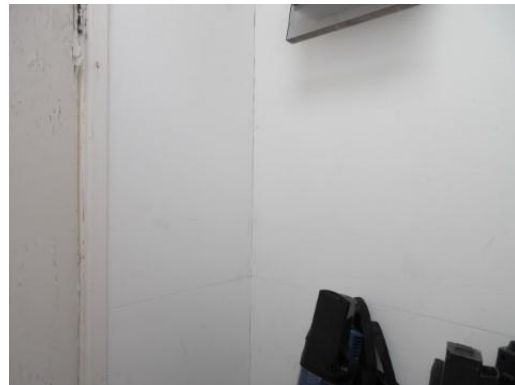
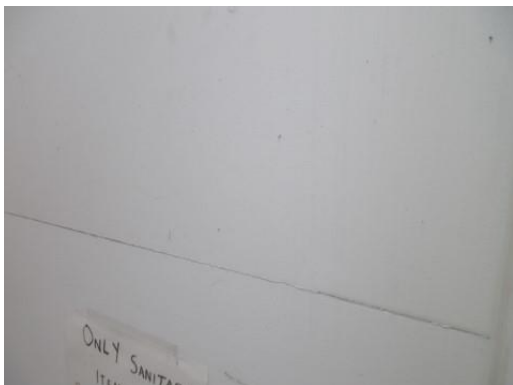
The internal walls are a combination of blockwork and stud with a panel finish, a combination of plasterboard and hardboard finishes. Joints are noted to be taped in areas and painted throughout. Slight soiling and undulations are noted though all generally appeared solid and in a reasonable condition.

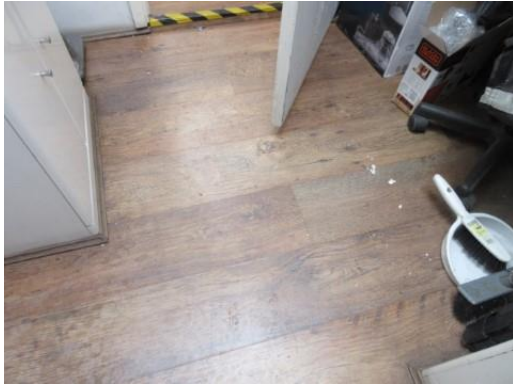
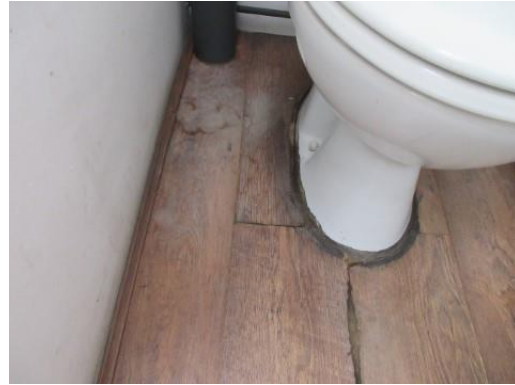
The laminate floor is heavily stained with water damage noted adjacent the WC and would benefit from replacement as required.

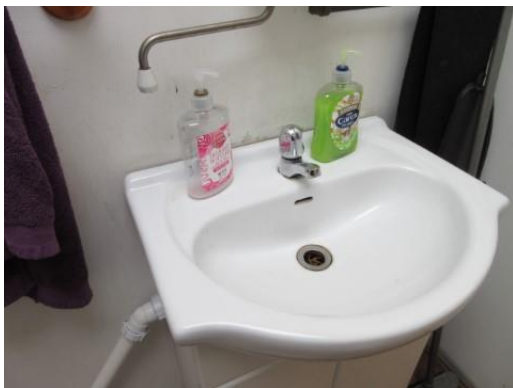
A small vanity unit was evident. The flow at the taps was satisfactory and drained away sufficiently with no obvious leaks noted. However, no splashback was provided therefore water damage may occur to the rear though was only stained at the time of the inspection.

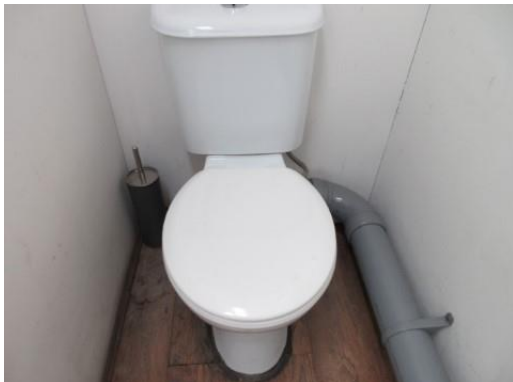
The low level WC was generally in a reasonable condition and in operative order.

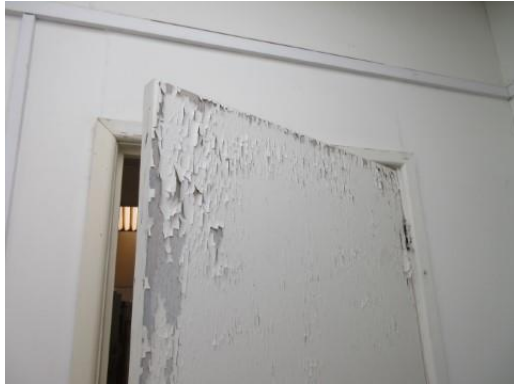
The internal painted flush door was in poor decorative order internally and would benefit from preparation and redecoration including all doorframes and architraves.

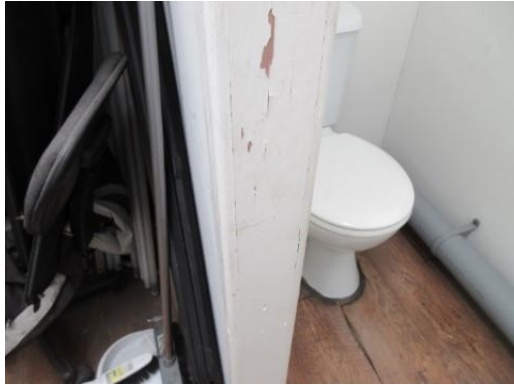
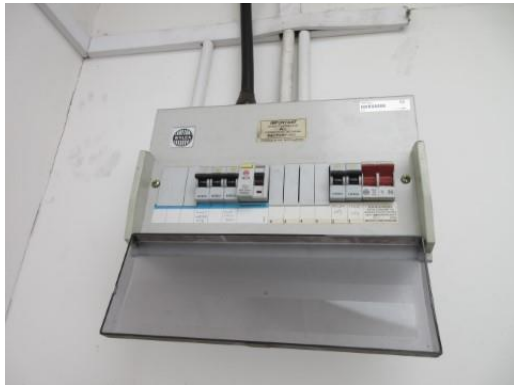
A distribution board was noted within the toilet area. RCD's were evident though no label indicating the last inspection date therefore we recommend a suitably qualified electrician test and inspect the distribution board and all associated circuits.

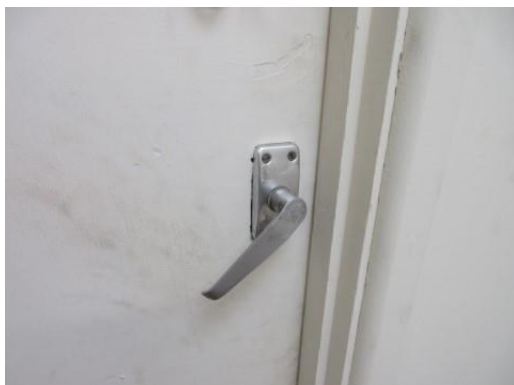
We note the handle to the door was slightly loose and would benefit from replacement.

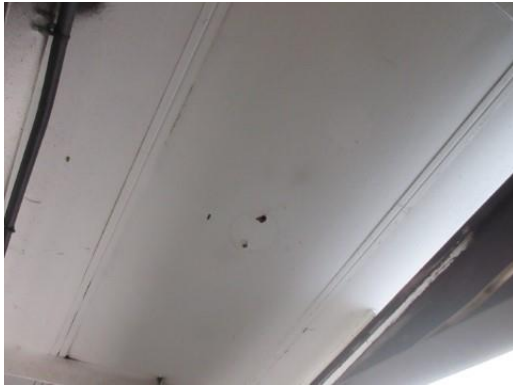
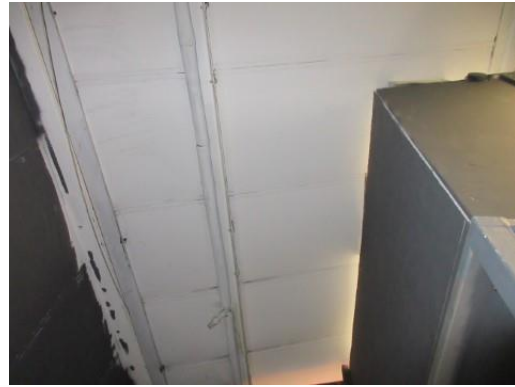
The underside of the main roof sheets is noted to be insulated board with a painted finish. Minor soiling and impact damage is evident, though no staining noted and all generally appeared to be in a reasonable condition.

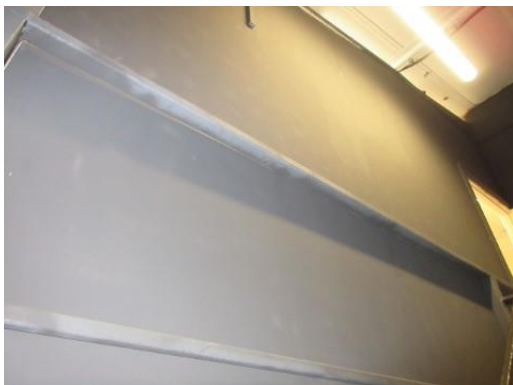
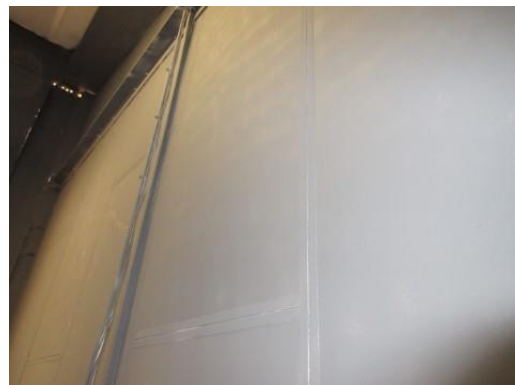
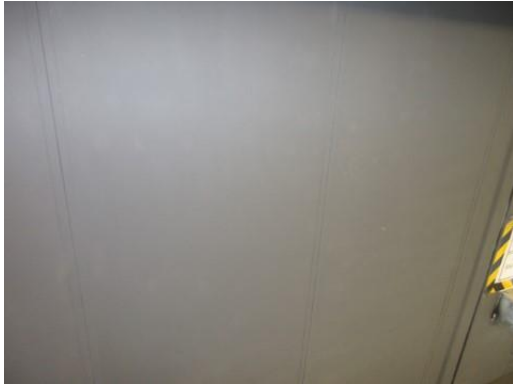
The internal walls are a combination of blockwork and stud with a panel finish, a combination of plasterboard and hardboard finishes. Joints are noted to be taped in areas and painted throughout. Slight soiling and undulations are noted though all generally appeared solid and in a reasonable condition.

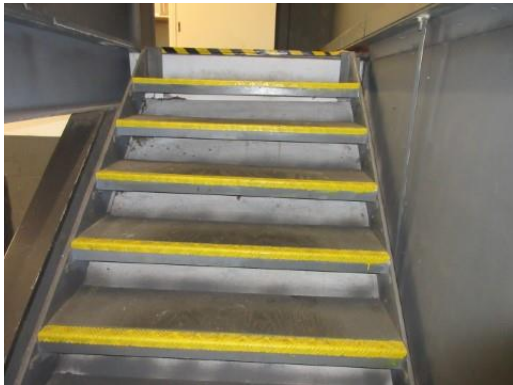
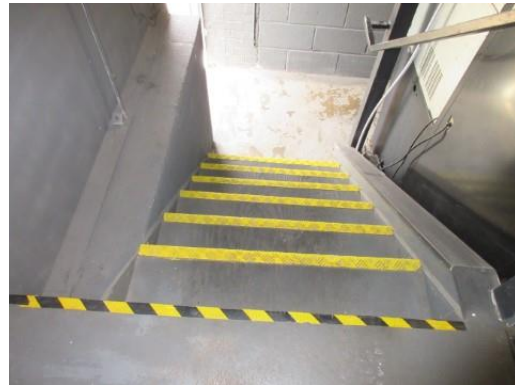
The steel staircase has been overboarded with painted plywood to the treads. General wear and tear is evident though all in a reasonable condition and feels solid underfoot.

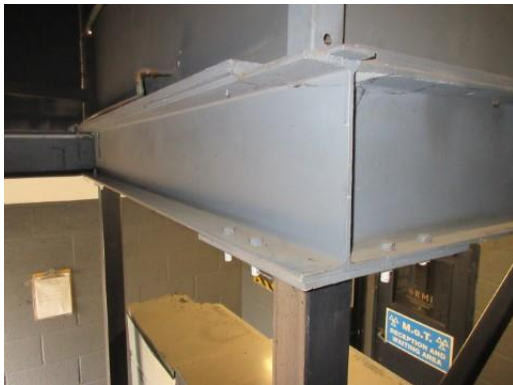
The structural steelwork forming the mezzanine and staircase generally appears in a reasonable condition with no obvious deviation evident.

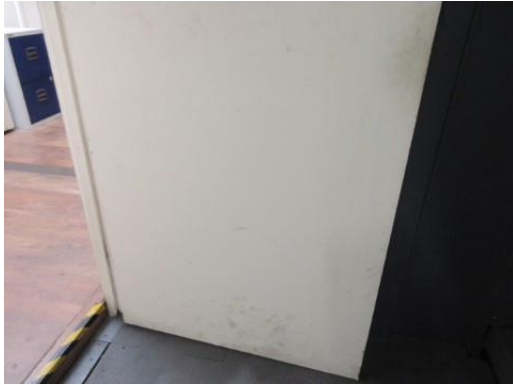
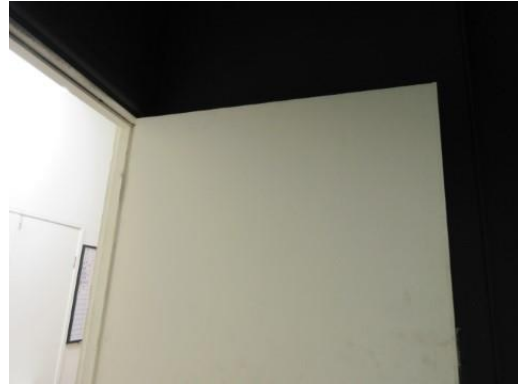
The internal door leading to the offices is noted to be an internal flush door which was in operative order, though was heavily scuffed, soiled and marked.

We also note that all internal doors and partitioning are not fireproof or do not conform to current Fire Regulations, as the general office is at first floor level. You may wish to consider a secondary means of escape be installed as may be required in the event of a fire.

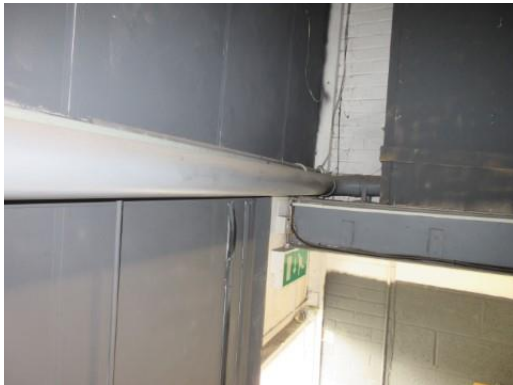
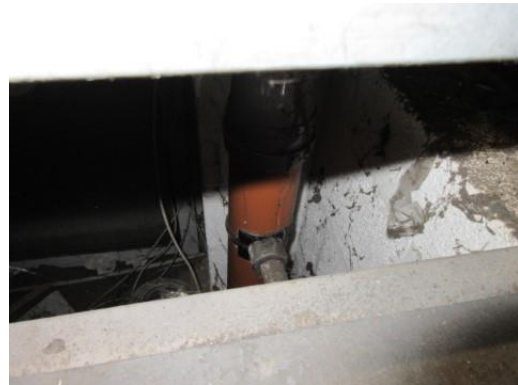
The internal drainage to the first floor toilet generally appeared to be in a reasonable condition, though we would recommend that a suitably qualified plumber ensures all in good operative condition with no obvious leaks.

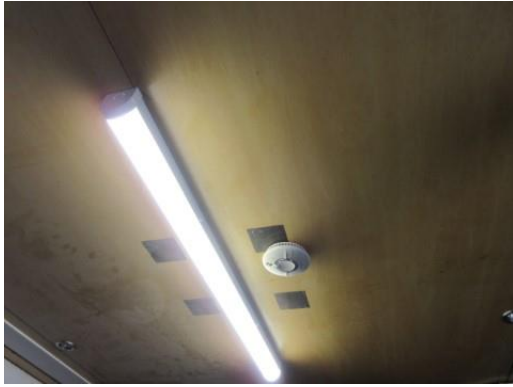
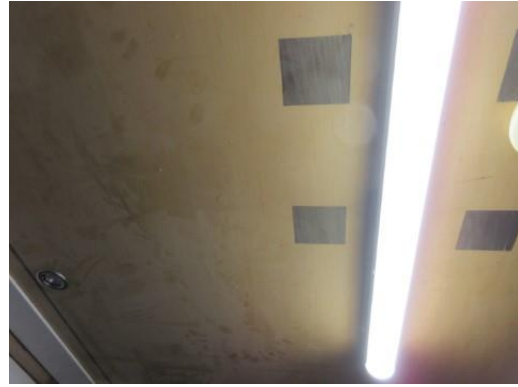
The ceiling is noted to be a plywood with a veneer. Minor areas of fixing holes and damage are evident though in general the ceiling appears to be in a reasonable condition.

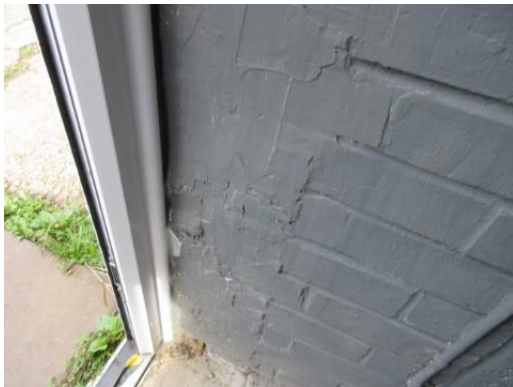
The walls are a combination of solid and stud partitioning painted finish. Minor areas of damaged pointing are noted to the internal blockwork adjacent the staircase with an area of impact damage adjacent the entrance door and when tested with a moisture meter no damp was evident.

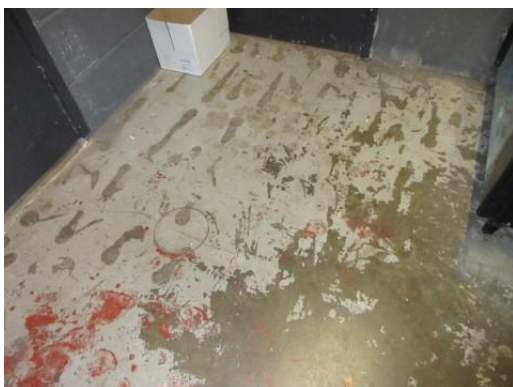
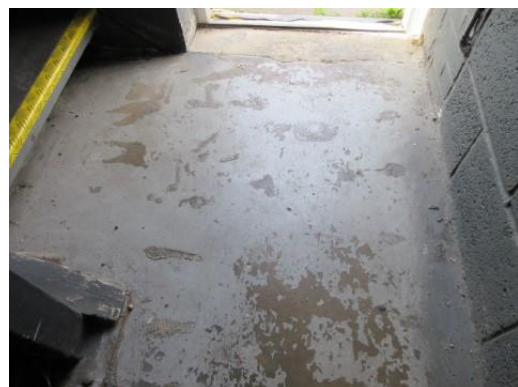
The floor was a solid concrete floor with a painted finish, heavily worn, scuffed and marked though solid and no cracks or unevenness is evident.

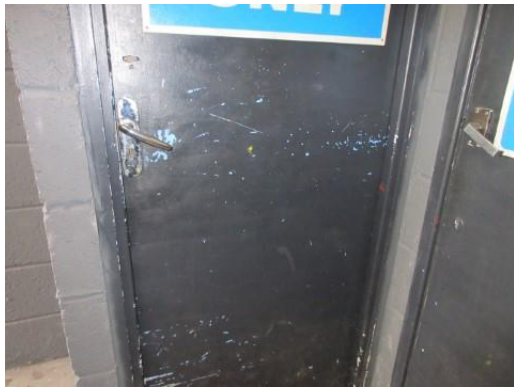
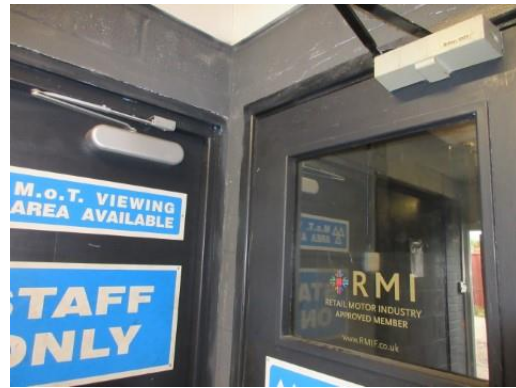
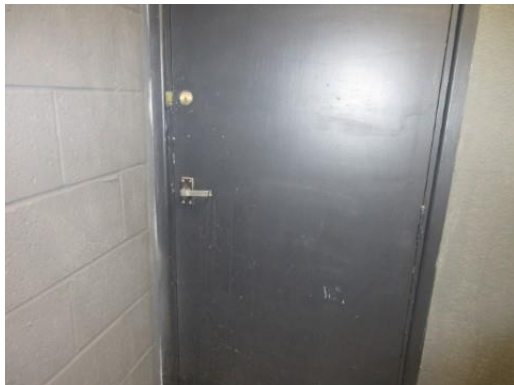
The internal doors are noted to be solid timber with the reception door noted to have a vision panel. All doors are chipped, scuffed and marked though all in operative order.

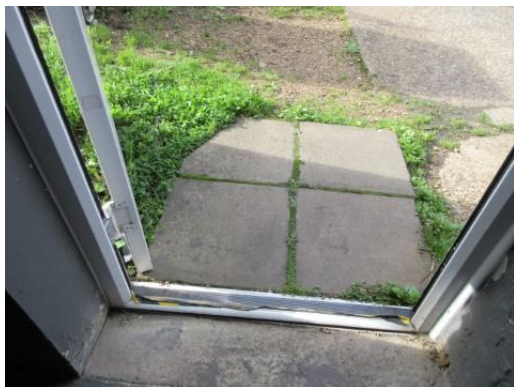
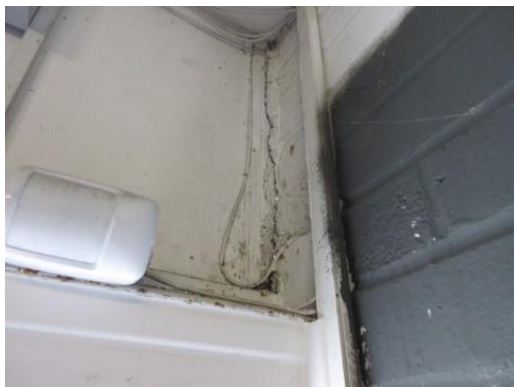
The external door is noted to be composite. We note the seal to the threshold is damaged and requires replacement. A small void is noted above the head of the doorway which should be infilled to prevent any water ingress which may cause dampness. Generally the door was in a good usable condition.

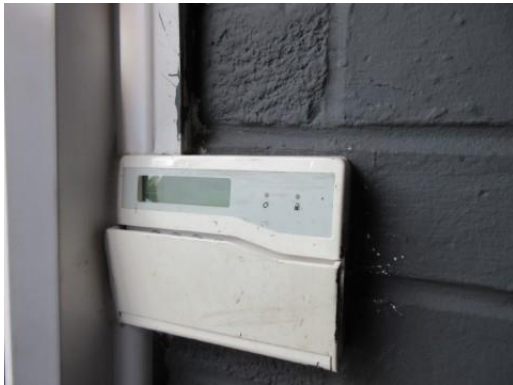
We note a burglar alarm was powered though was untested therefore we recommend all service and maintenance be provided to confirm all in good condition.

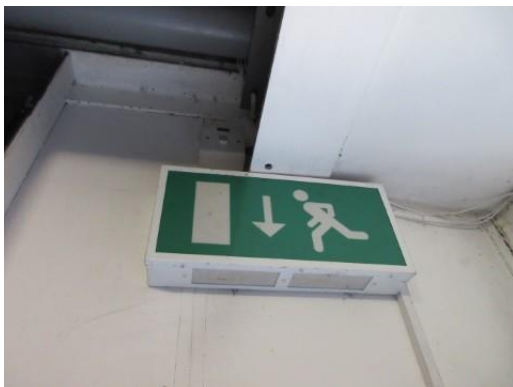
The emergency lighting system was untested. We recommend this is tested as part of general fire procedures and all confirmed in good working condition.

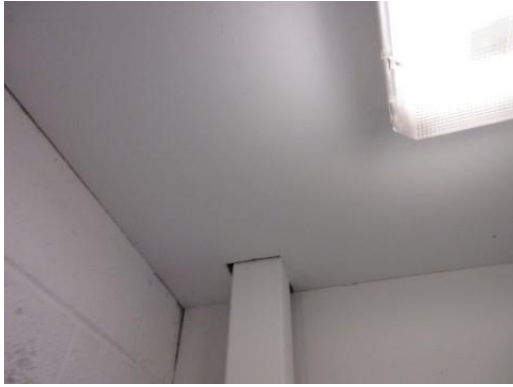
The ceiling is noted to be painted plywood boarding and generally appears in a reasonable condition with no obvious defects noted.

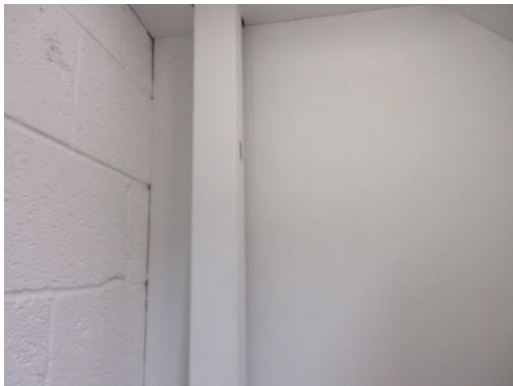
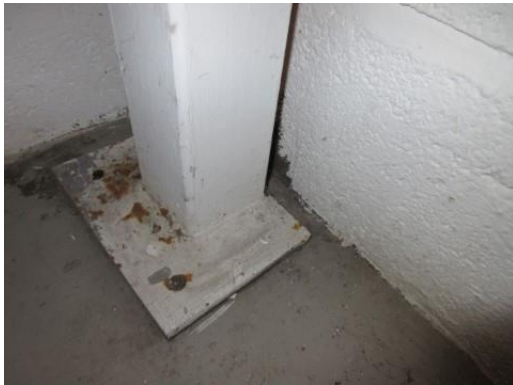
The steel support to the staircase generally appears in a reasonable condition however we did note that the base plate had been cut and the bolts not installed. However, no movement or cracking was evident to the mezzanine or adjacent structure.

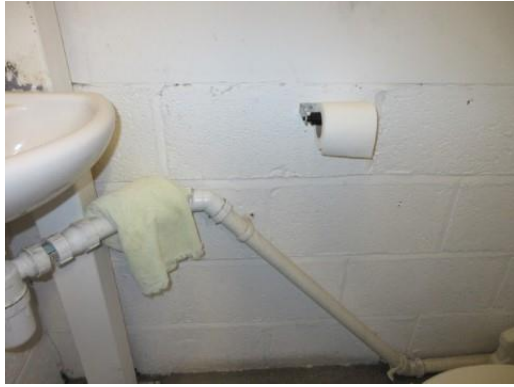
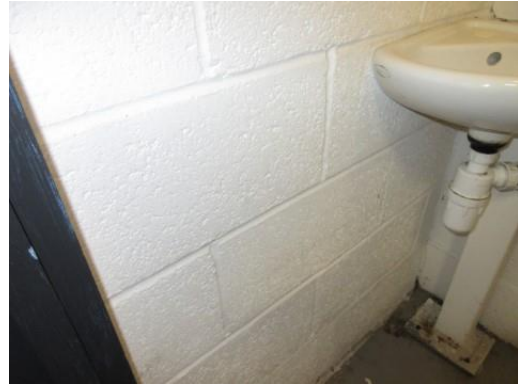
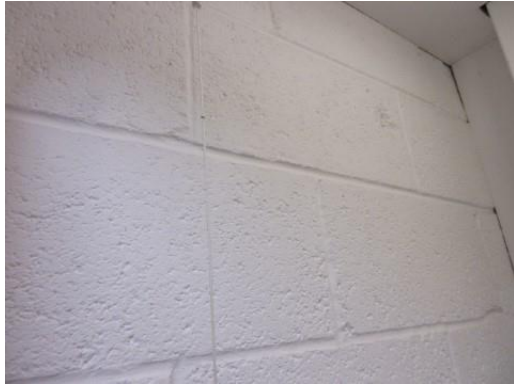
The walls were painted blockwork and generally appeared in a reasonable condition with no cracking evident.

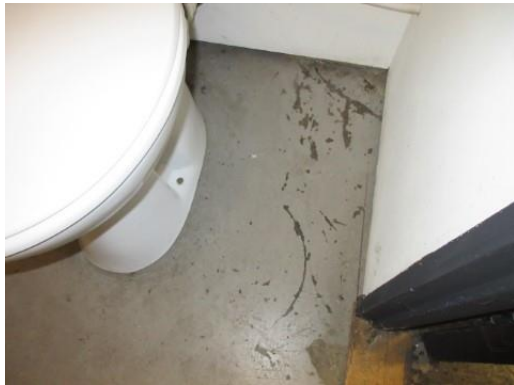
The concrete floor was over painted and score marks and scuffs were evident however the floor was solid and firm underfoot with no dampness noted.

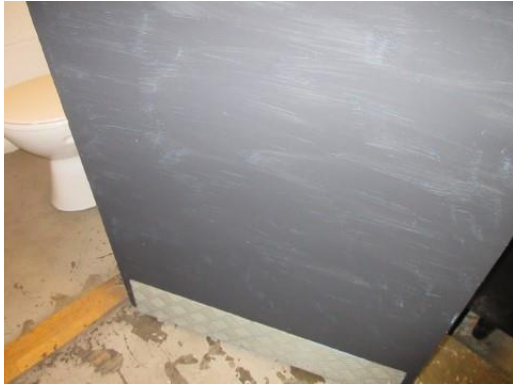
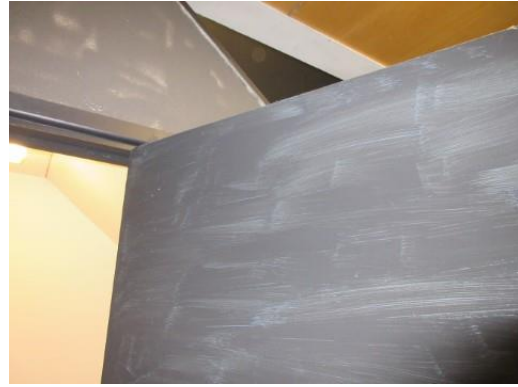
The sanitaryware consisted of a wall mounted basin and low level WC. The flow at the taps was satisfactory and drained away sufficiently with no obvious leaks noted.

The internal flush door with painted finish was noted to be scuffed and marked though all in a reasonable condition.

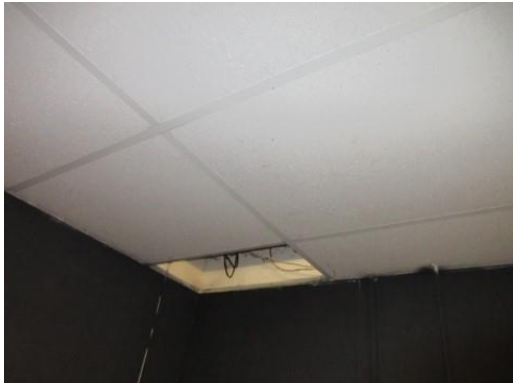
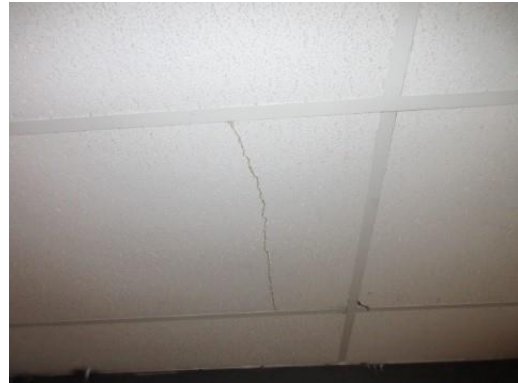
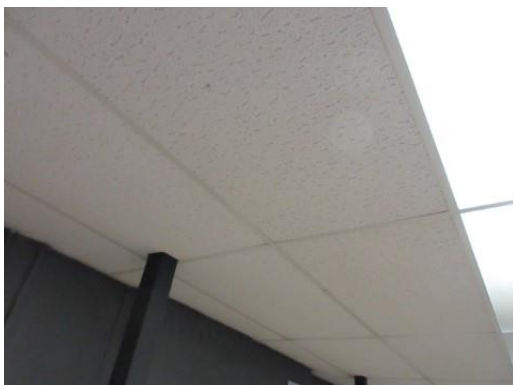
The ceiling is noted to be a suspended metal grid with inset mineral fibre ceiling tiles. The tiles are noted to be heavily soiled with 1 no. missing to the rear corner and an adjacent tile cracked, however is generally fit for purpose.

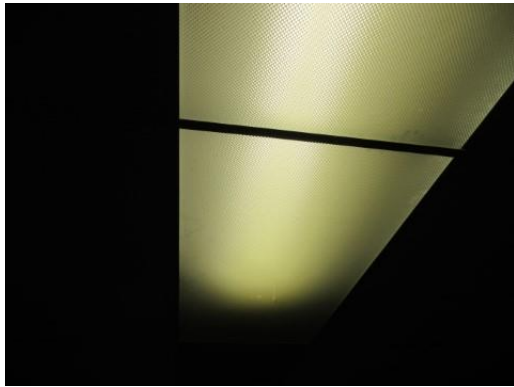
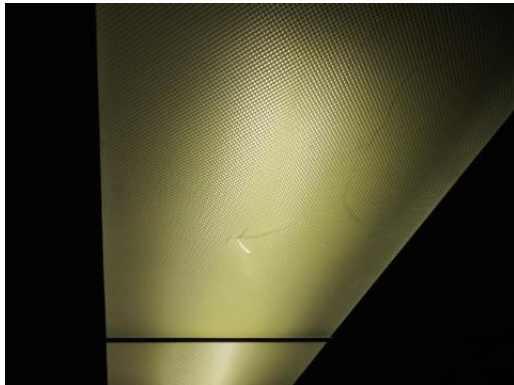
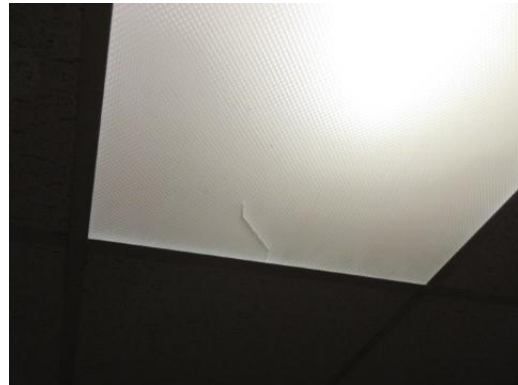
The diffusers were noted to be heavily soiled with 4 no. noted to be damaged.

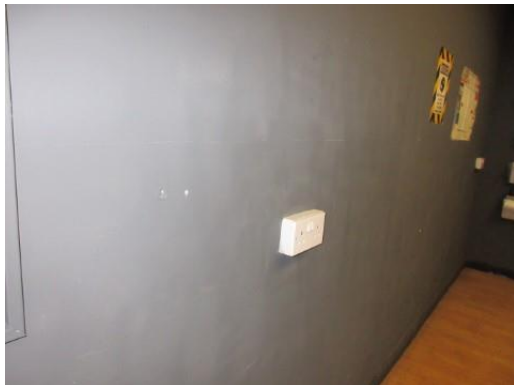
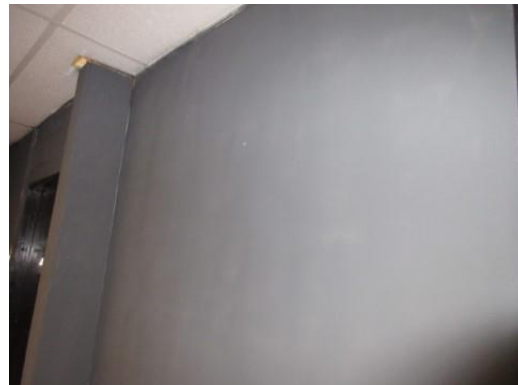
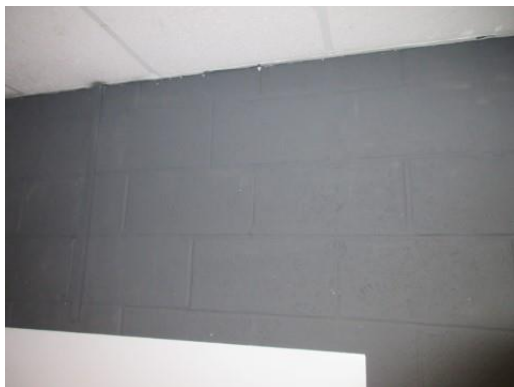
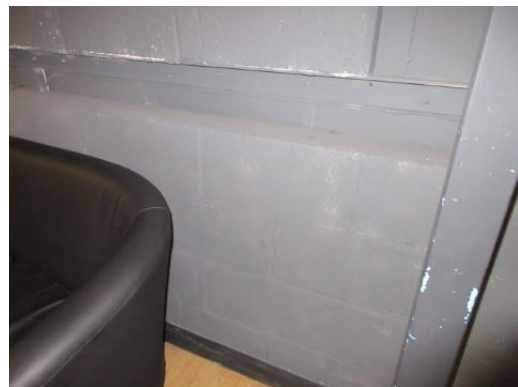
The walls are a combination of solid and stud partition with a painted finish. Slight unevenness, scuffs and marks were noted though no structural issues were evident.

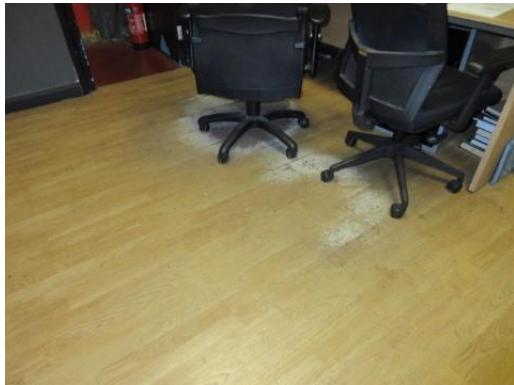
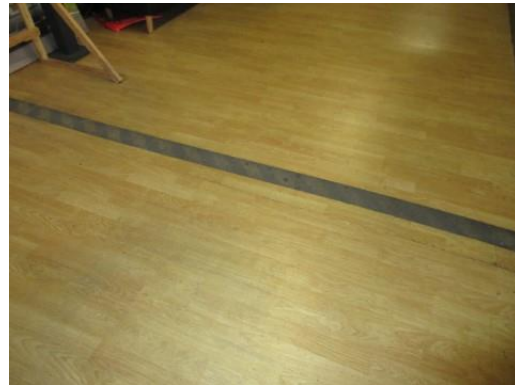
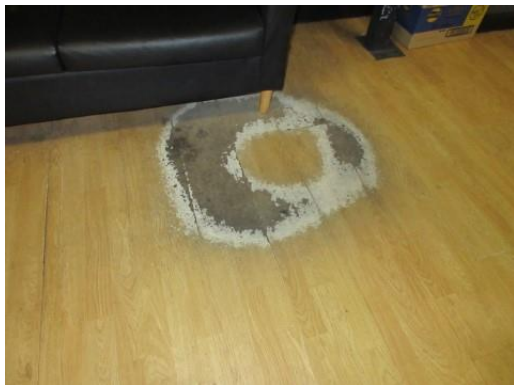
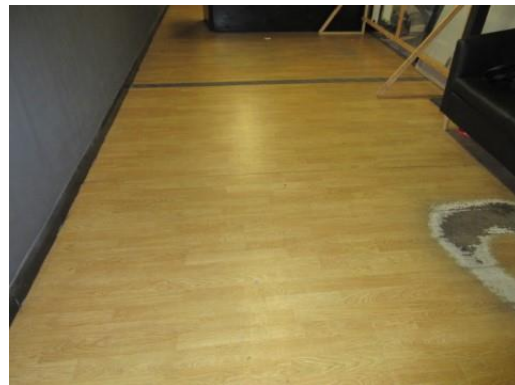
The solid floor has been overlaid with laminate floor finish. Slight unevenness and general wear and tear is noted and will benefit from replacement when funds allow.

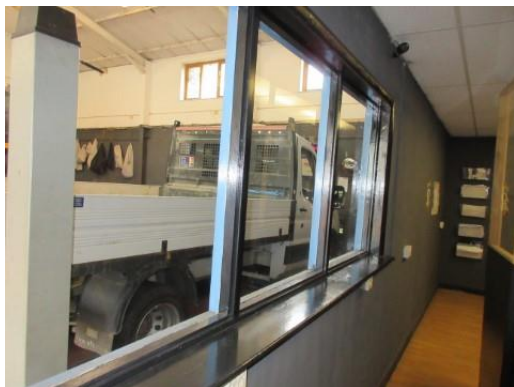
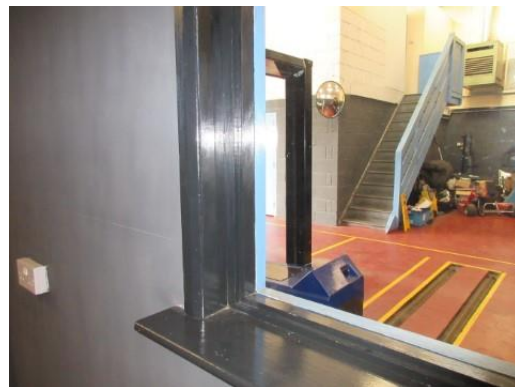
The internal single glazed painted timber window within the viewing area is generally in a satisfactory condition with no obvious defects noted.

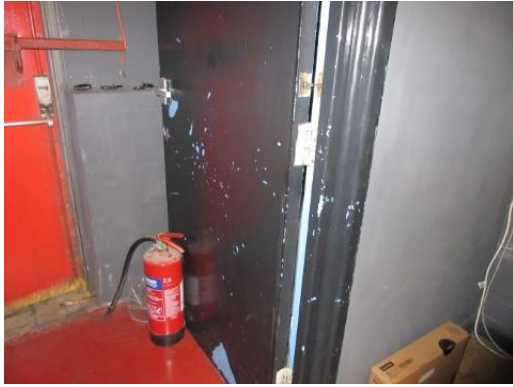
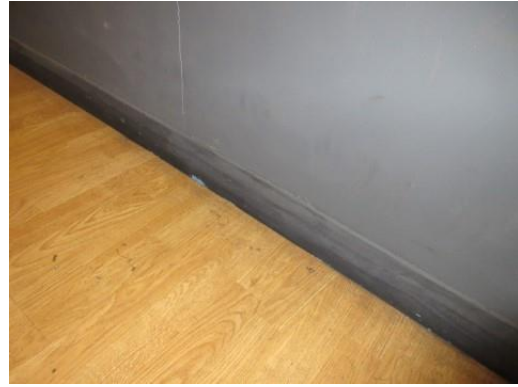
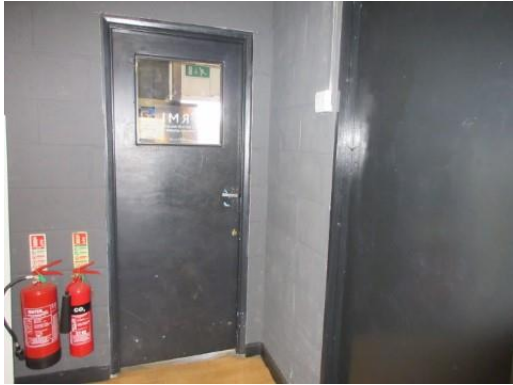
The internal joinery consists of flush painted doors, gloss painted skirting, frames and architraves. All areas were noted to be scuffed and marked though generally in a usable condition.

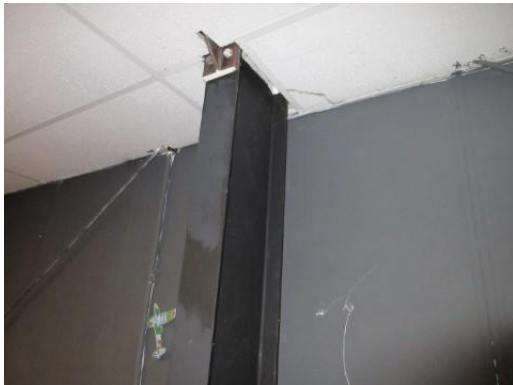
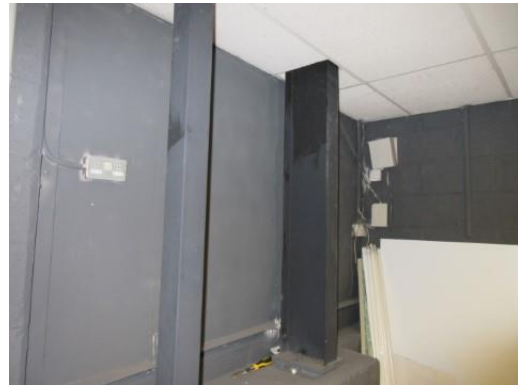
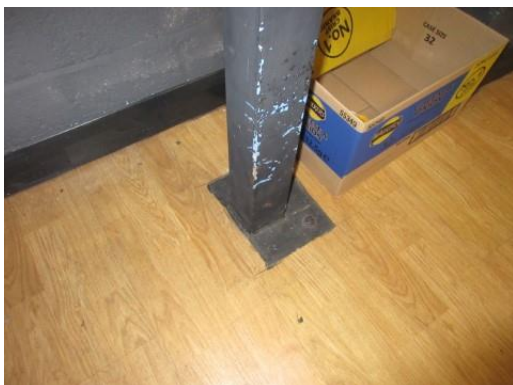
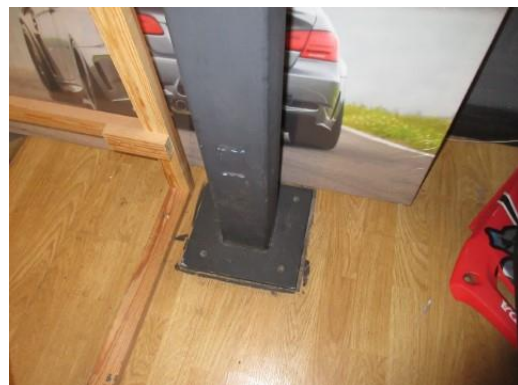
The painted steel column to the portal frame and internal supports for the mezzanine were noted to be scuffed and marked. 1 no. base plate has been cut down however this does not appear to be affecting the performance of the steelwork and no movement was evident.

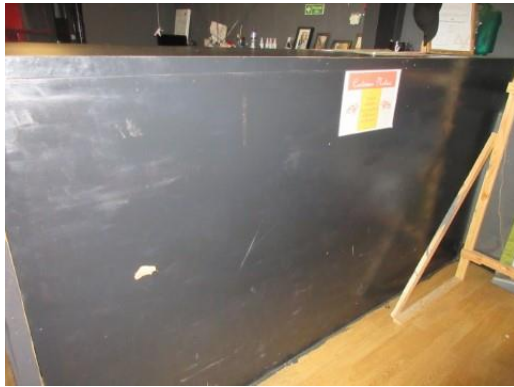
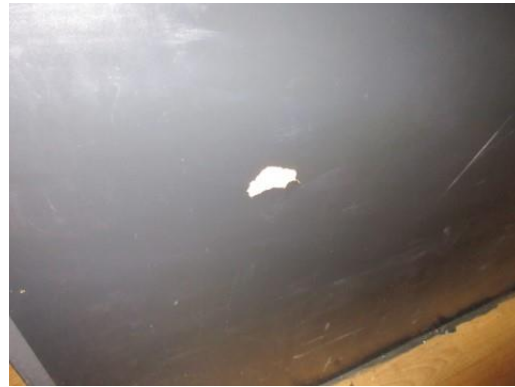
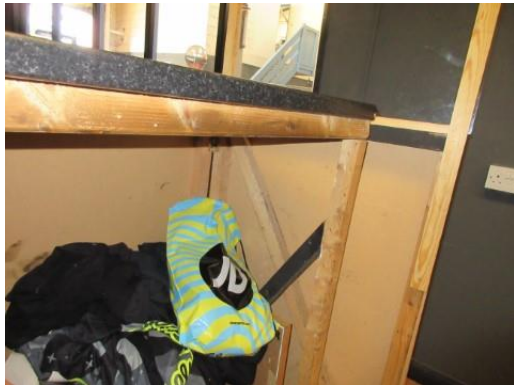
The hardboard covering to the front of the counter was noted to be damaged, the worktop chipped and marked though generally fit for purpose, however movement was evident and would benefit from extra diagonal bracing to prevent movement.

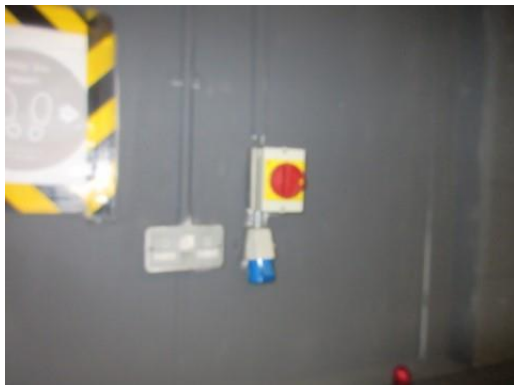
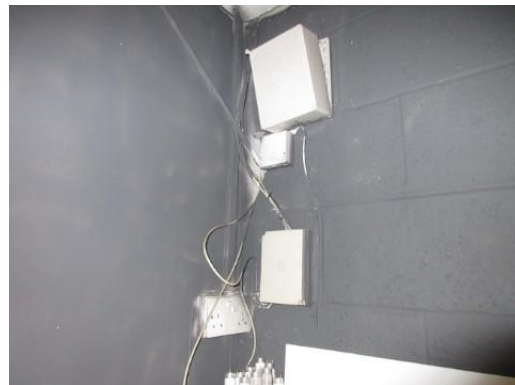
The electrics were untested at the time of the inspection therefore we recommend a suitably qualified electrician test and inspect the electrical circuits and rectify any defects at this time.

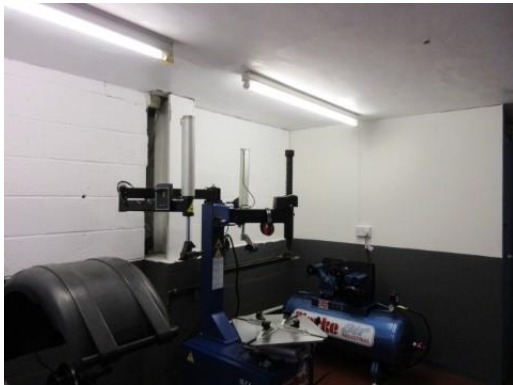
The ceiling is noted to be plasterboard and skim with a painted finish. The finish is noted to be patch painted and the rear section overboarded with no taped joints evident, however, generally in a reasonable condition.
