# Building Inspection Report

People Express Taxis  
Unit 2, rear of 25 Somers  
Rugby  
CV22 7DG

Report date: 5<sup>th</sup> October 2023

**Job reference:** MD/SR/21780

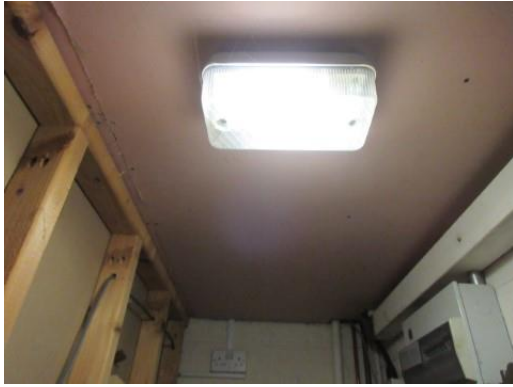
The walls are noted to be stud partitioning with a plasterboard finish. No finish has been applied to the stud partition board sheets with no sheeting noted internally to the left-hand side however this does not appear to be affecting the performance of the studwork wall.

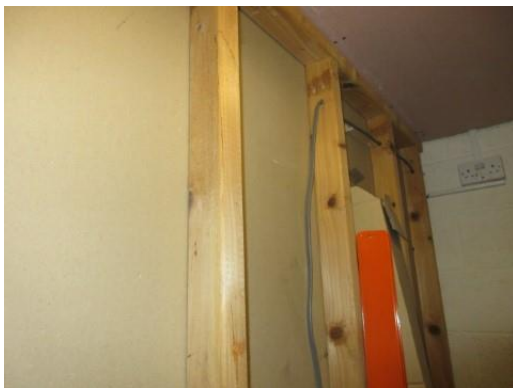
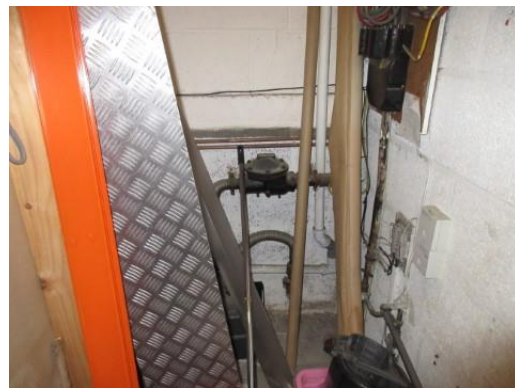
The distribution board was noted to be located on the right-hand wall and all generally appeared to be in a reasonable condition. We would recommend that a suitably qualified electrician test and recommission the electrical supply to the ground floor areas, identify and rectify any defects as required.

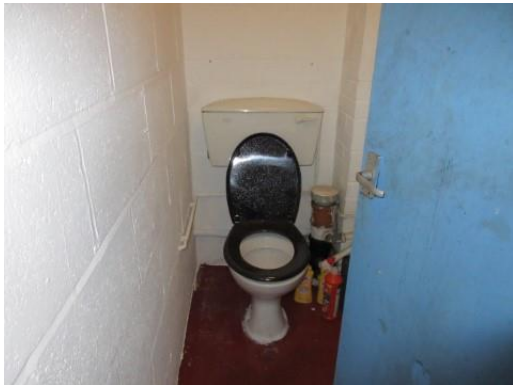
The ceiling is noted to be plasterboard and skim with a painted finish. We note that the finish is patch painted with slight damage to the rear corner.

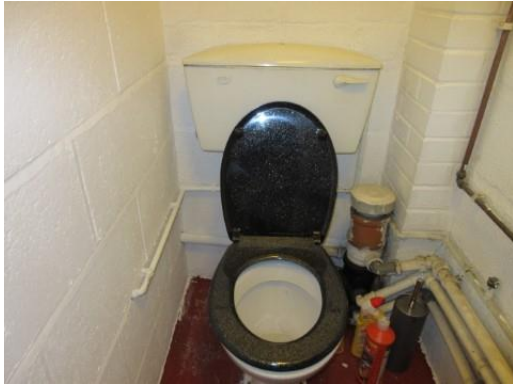
The solid concrete floor with a painted finish was scuffed and marked, slightly stained around the WC but generally in a reasonable condition.

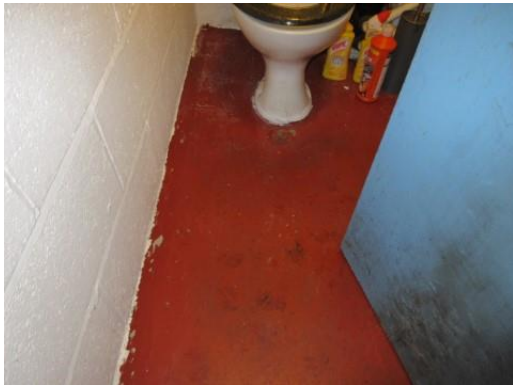
The joinery was noted to be scuffed and marked, soiled to the external face of the internal door though generally appeared in a reasonable condition and in operative order.

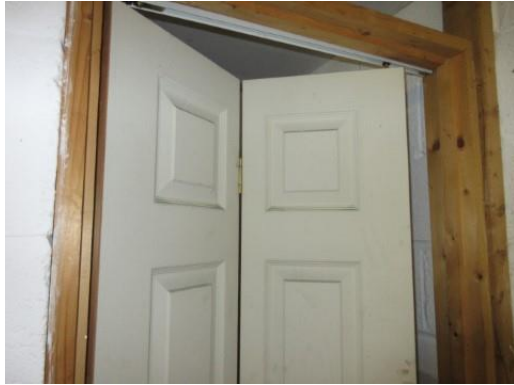
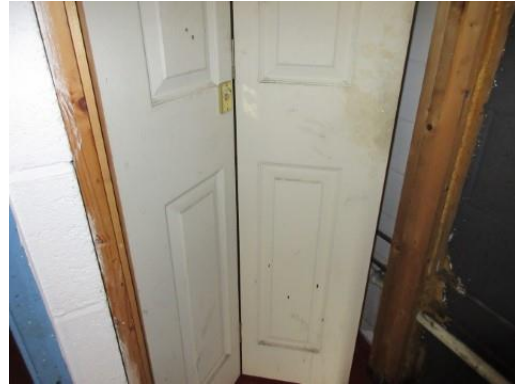
We note that the vertical stud to the frame of the door to the urinal is split and does not continue beneath the pipework, though no obvious movement was evident on the day of the survey.

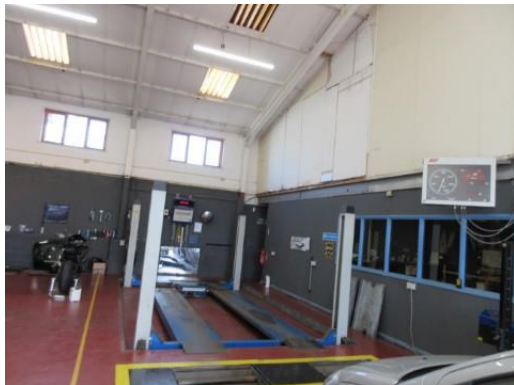
The underside of the main ceiling is noted to be insulated panels. Slight undulations are evident with minor bowing of the panels however no structural movement is noted on the day of the inspection.

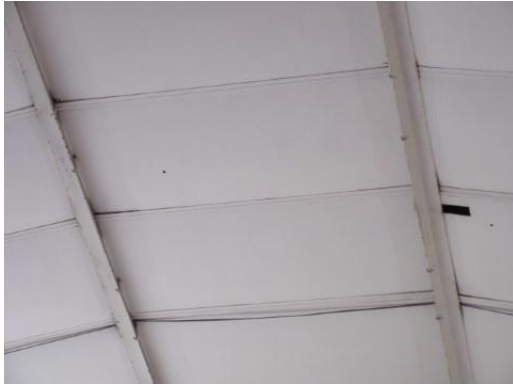
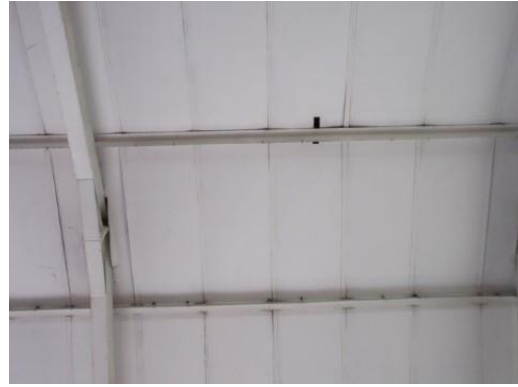
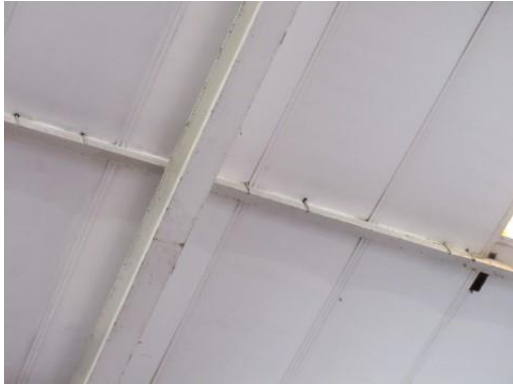
The purlins were slightly soiled though no deviation was evident and all was generally in a reasonable condition.

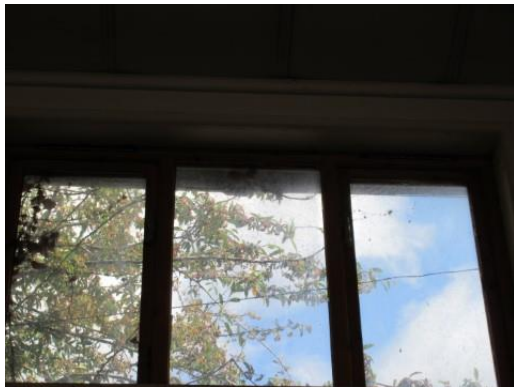
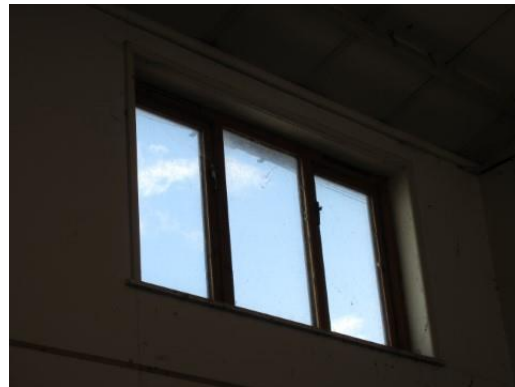
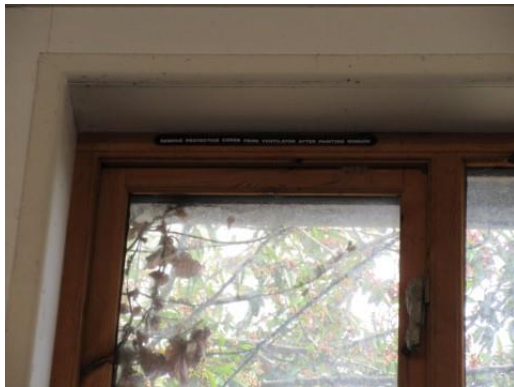
The internal joinery was noted to be scuffed and marked and would benefit from preparation and redecoration throughout.

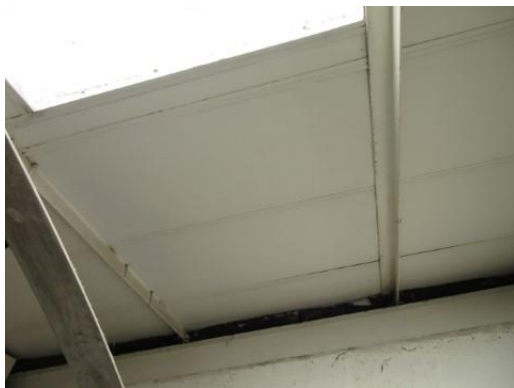
The purlins were generally soiled. Minor corrosion was noted and would benefit from preparation and redecoration.

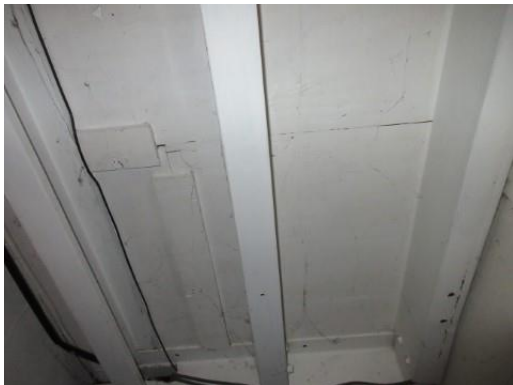
The walls are noted to be clad with plasterboard at high level with blockwork at low level. All walls scuffed and marked though generally fit for purpose with no structural movement noted.

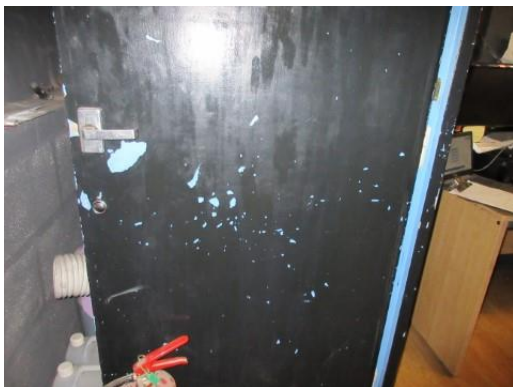
The timber fire escape door was untested as a security bar was installed. We did note however that the low level section is heavily decayed and may not fit within the aperture once opened. We recommend that this is repaired/replaced in the immediate term and confirmed as in good working condition.

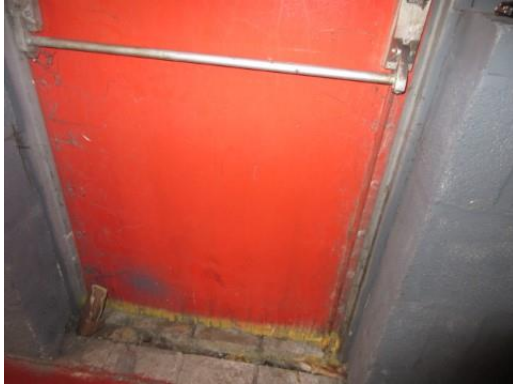
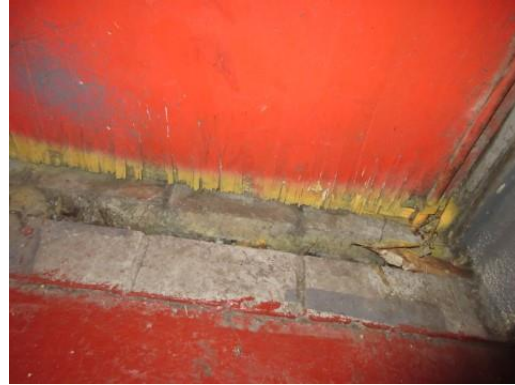
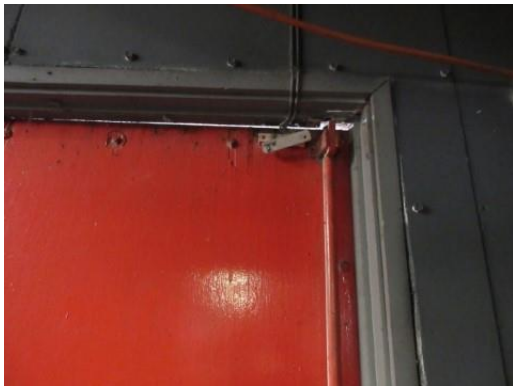
A small void was noted to the threshold. We recommend this is infilled or over plated to prevent any accidents when the door exit is utilised.

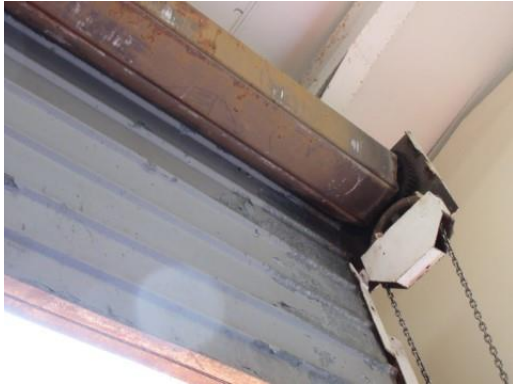
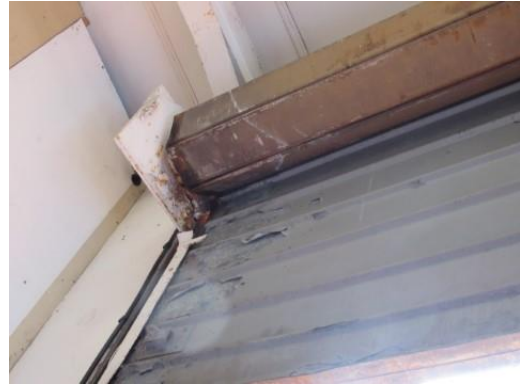
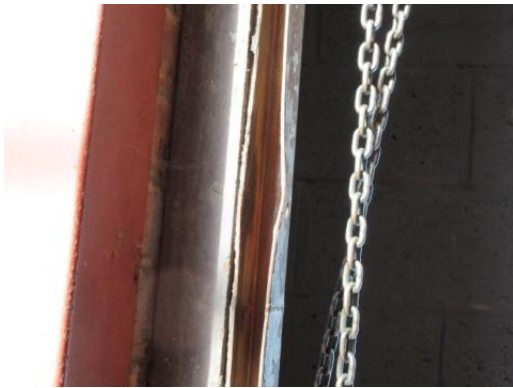
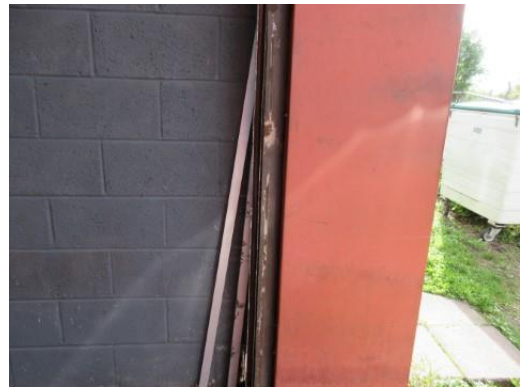
The internal roller shutter is galvanised steel and was in operative order however was in poor decorative order. We recommend servicing as we also note that the guides were out of alignment and confirmation all in good operative order.
